Hopedale Town Hall Renovation Project

Building Conditions Assessment and Recommendations Report

Bargmann Hendrie + Archetype, Inc.
Boston, Massachusetts

for
Town of Hopedale, Massachusetts
January 2013

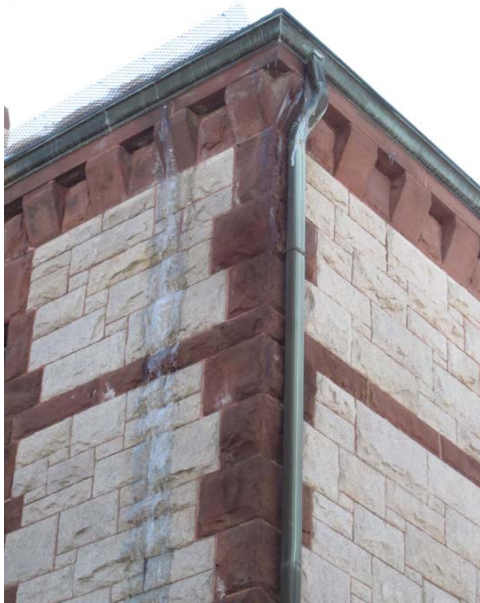
The roof should be looked at more closely. Deteriorated gutters are resulting in moisture getting into the brownstone cornice and running down the face of the building. Some slates are broken. This, along with worn valleys and gutters, might dictate roofing work is needed to prevent water infiltration to the interior.

Frozen water at stone resulting from gutter leak.

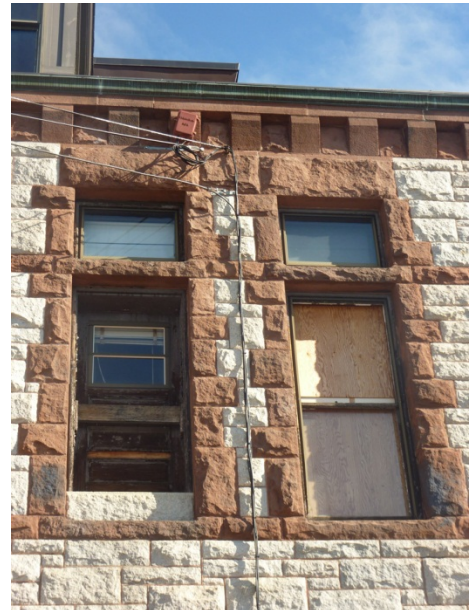
Windows include some original wood windows as well as some aluminum replacement windows and aluminum storm windows. All windows are in need of work, either with replacement or restoration.

A range of window conditions exist.

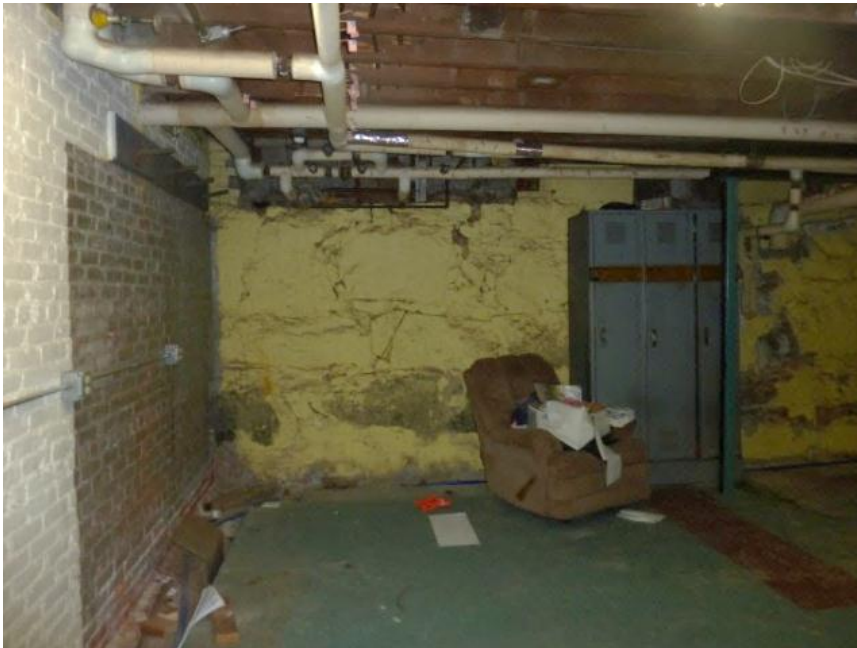
The interior bearing walls are constructed of unreinforced brick and are painted. These walls are in good to fair condition overall, but the base of the south and west walls of the northeast storage room and the west wall of the center storage room have missing mortar and spalling brick due to moisture damage. Cased window openings in some of the interior bearing walls, basement exterior storefront windows, and original toilet rooms are indications that at least some of the basement was originally used as occupied space.

Stone exterior wall, brick load-bearing interior wall, and concrete floor in northeast storage room.

Once finishes can be removed, inspect for additional moisture damage and repair.
Remove spalled brick at wall bases, and repoint mortar where deteriorated.

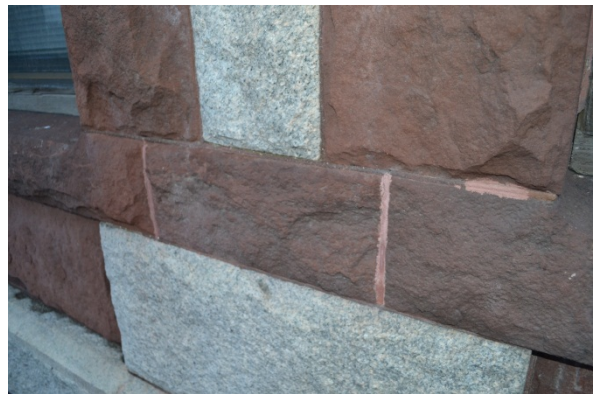
The grapevine joint mortar is a dark pink with noticeable pink and white aggregate. There are some deteriorating mortar joints at various locations and other areas of spot repointing. The poor and messy application of an incompatible mortar does not match the color or texture of the original mortar.

Incompatible mortar at a few stone locations.

Cut and repoint missing, deteriorating, and incompatible mortar

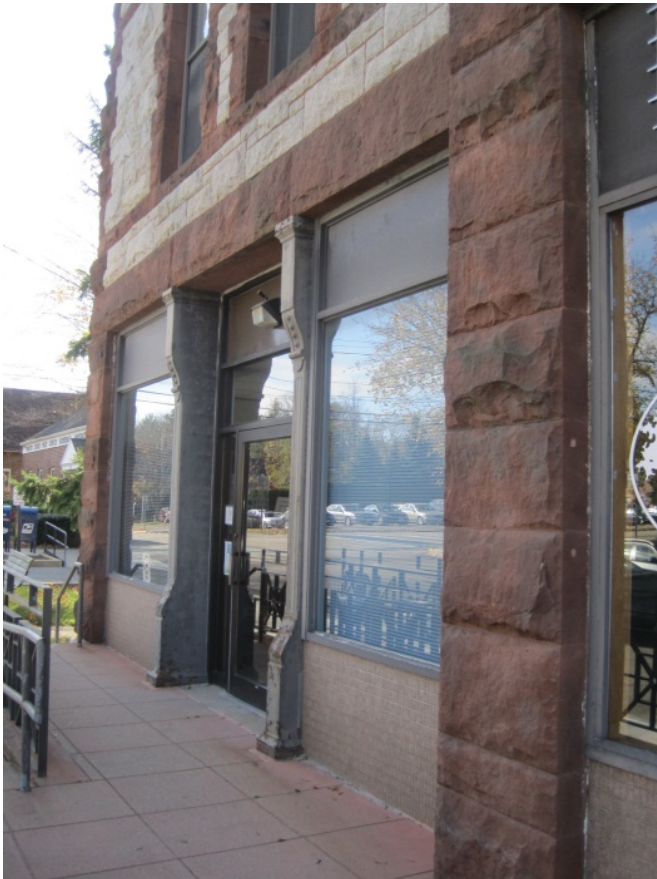
The storefronts on the north façade are replacements, with stone tile replacing the original wood paneling. The cast iron pilasters are rusting due to peeling paint and being exposed to the weather.

Aluminum storefront windows at north elevation.

Remove and replace the aluminum storefront windows (Type D).

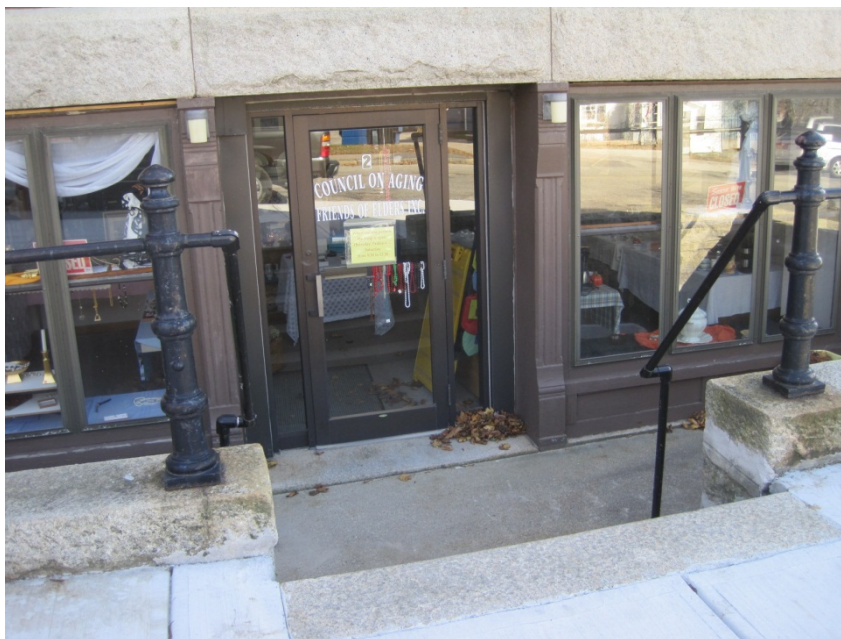
The Council on Aging room's storefront windows and wood paneling are original, but the storm windows were added at a later date. The wood trim around the windows seem to be in good condition. The top trim piece on the south window has been replaced, but not painted. The wood trim at the paneling is deteriorating, especially near the water drain.

Original wood framed storefront windows at Council on Aging basement entrance.

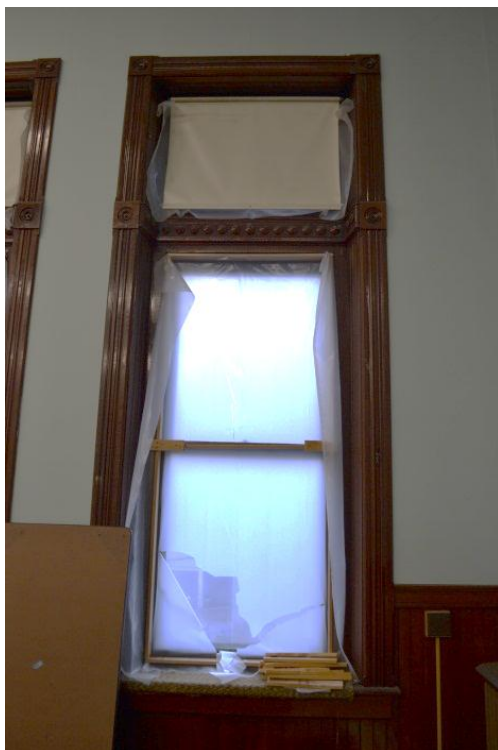
Interior of window at auditorium. Windows have temporary frames and plastic around them to keep out air infiltration.

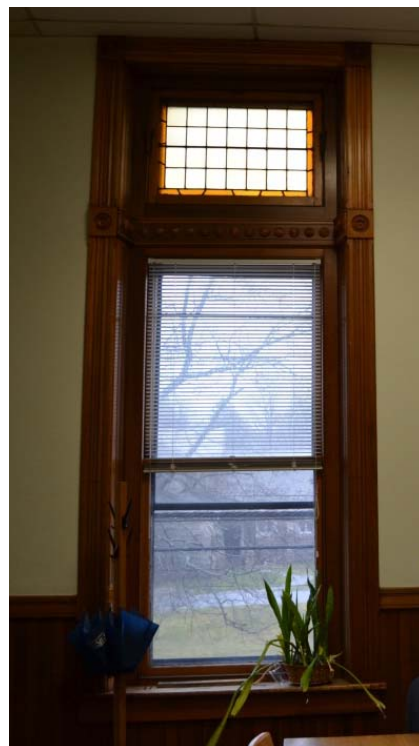
Interior of window at second floor conference room. Wood double hung sash and leaded glass in fair condition.

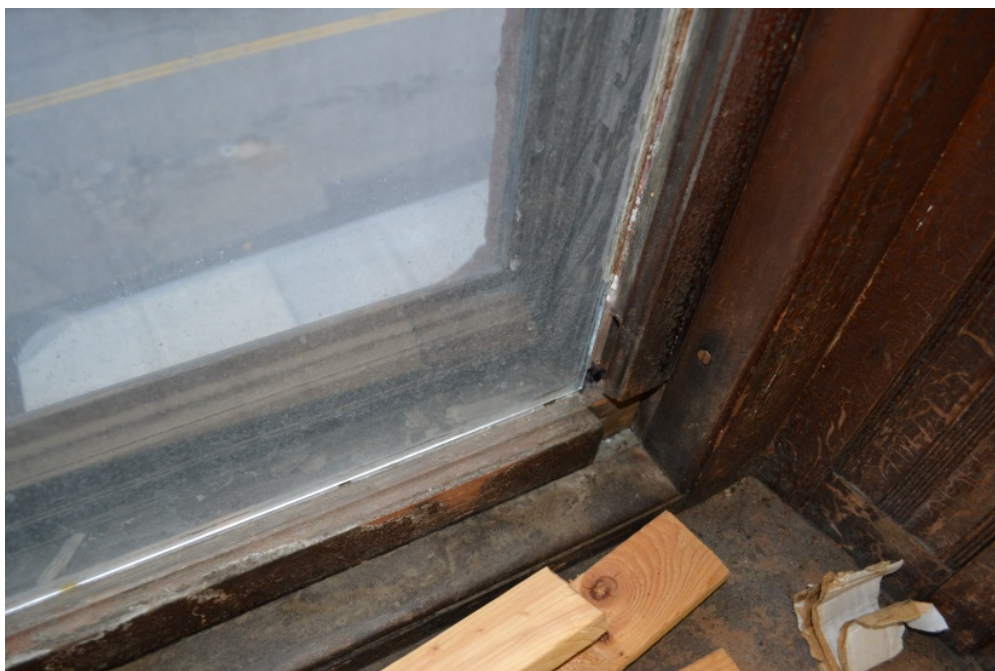
Broken wood sash at auditorium window.

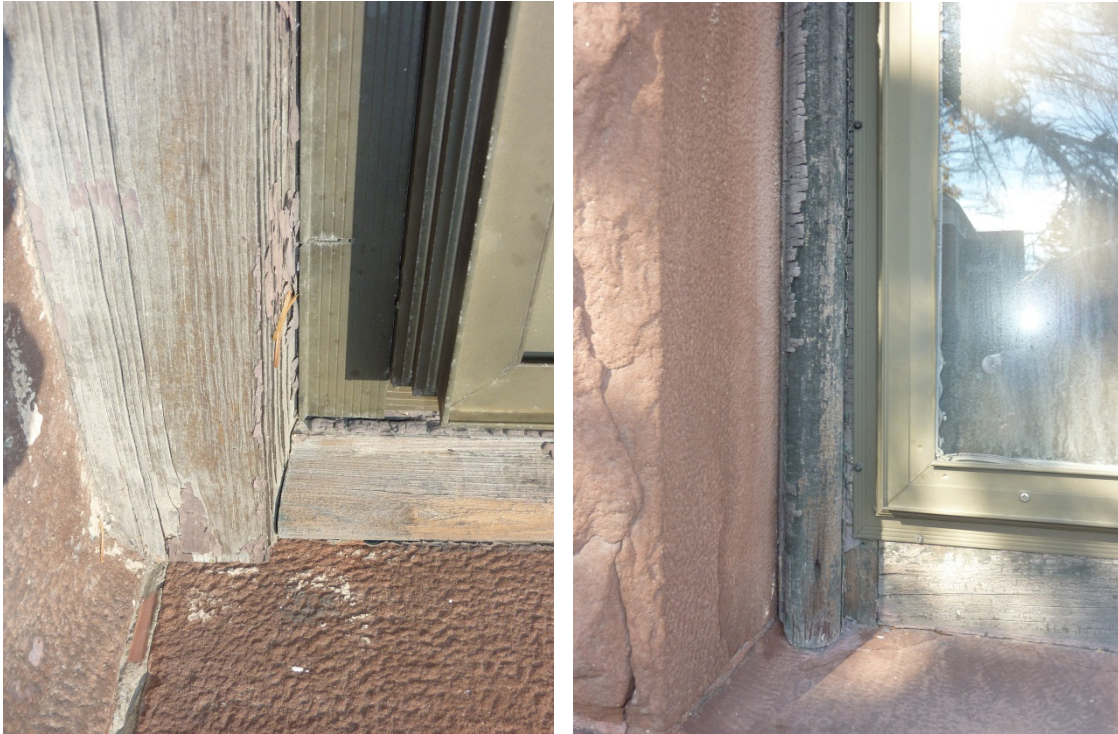
Exposed wood exterior trim with storm window screwed to wood frame.

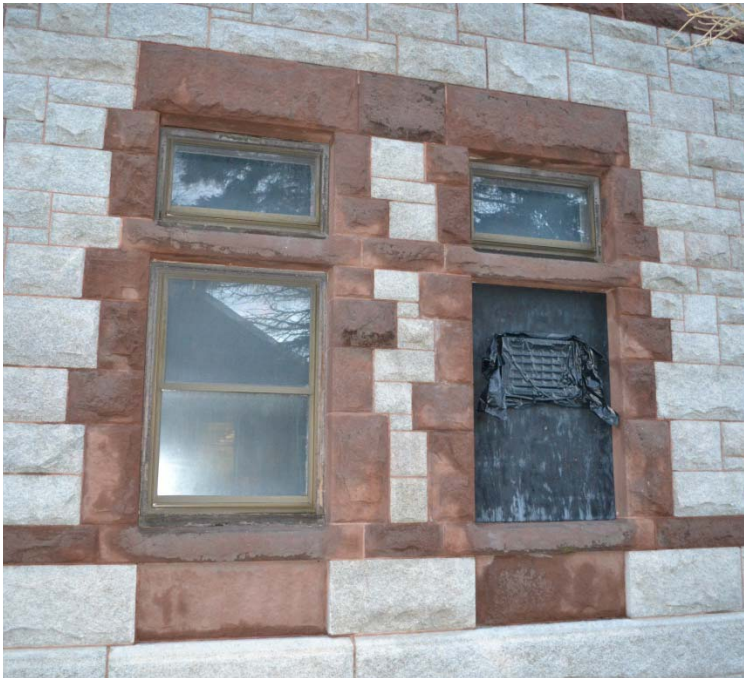
First floor east windows boarded from interior with wood veneer and exterior with plywood.

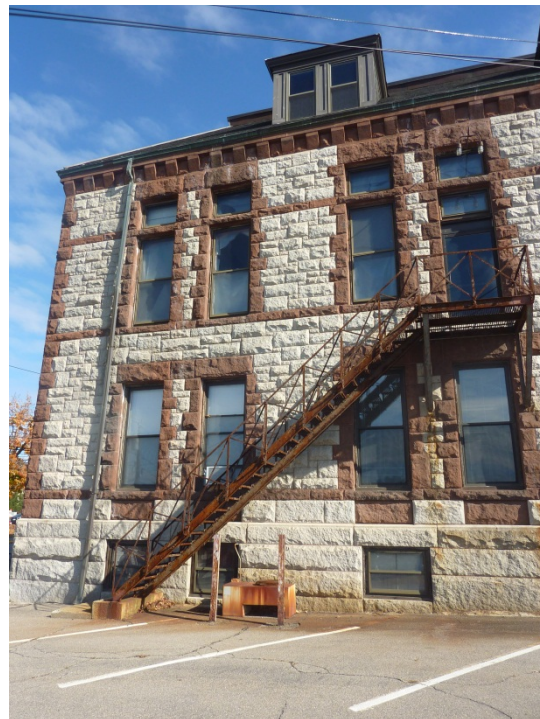
Rusting fire escape at south elevation.

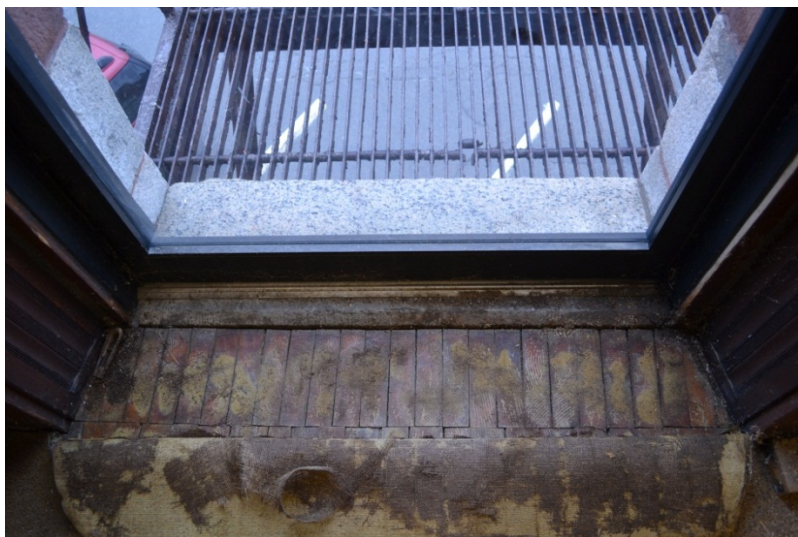
At an unknown date, the easternmost window on the south wall of the auditorium was removed and replaced with an emergency exit door and metal fire escape. The signs that it was not always a door are the different stone type at the exterior threshold and the break in the original wood flooring at the interior wall. The metal stair has an open grate landing and open risers.

Emergency egress door at auditorium was a later addition

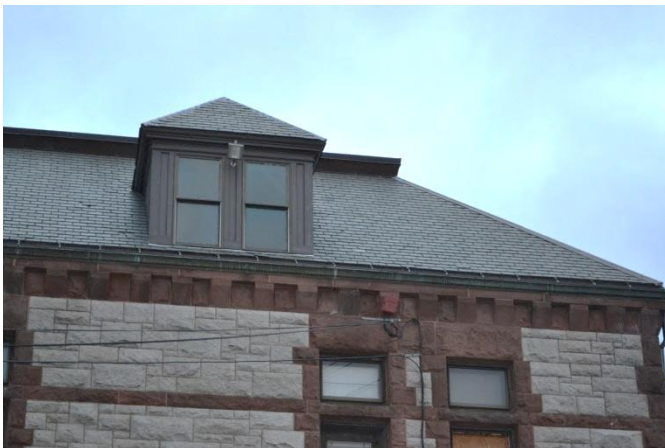
Worn gutters and missing slate on roof at south elevation.

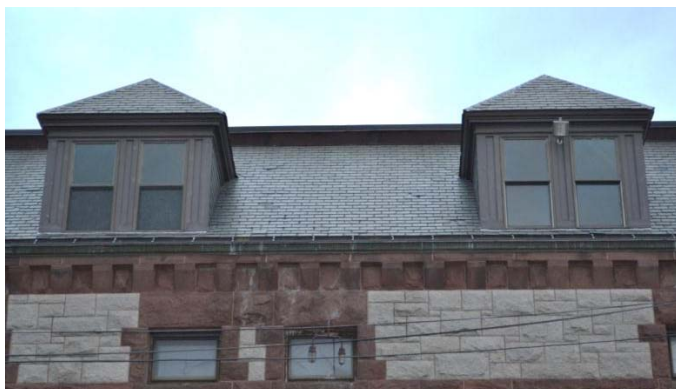
Staining on granite, worn gutters, and some missing slate at south elevation.

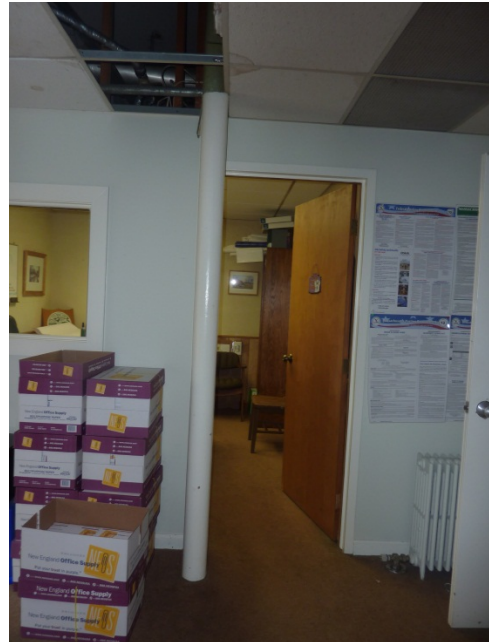
Original cast iron column blocks required clearances to Town Administrator's office.

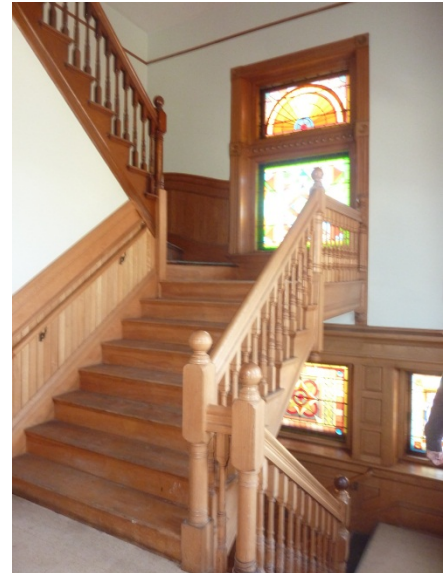
The flight of stairs from the second floor to the attic has two winder stairs which means that the stairs do not have uniform tread widths and is not in compliance with MAAB. Action will depend on the use and occupancy in the attic. The first 8 risers before the winders are 7-1/4" tall while the rest of the risers to the attic are 8-1/4" tall. Six balusters are missing at the top of the attic stairs.

Stair leading to attic.

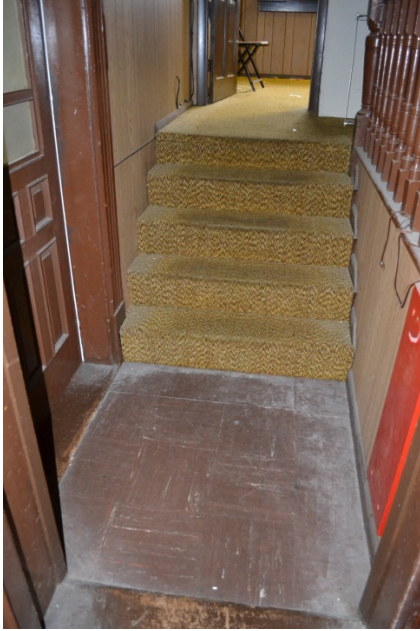
Stair to backstage does not have handrails

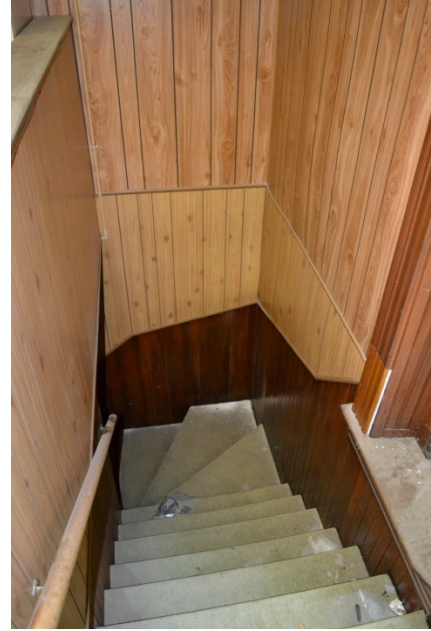
Southeast stair from first to second floor has winders and collides with the existing window.

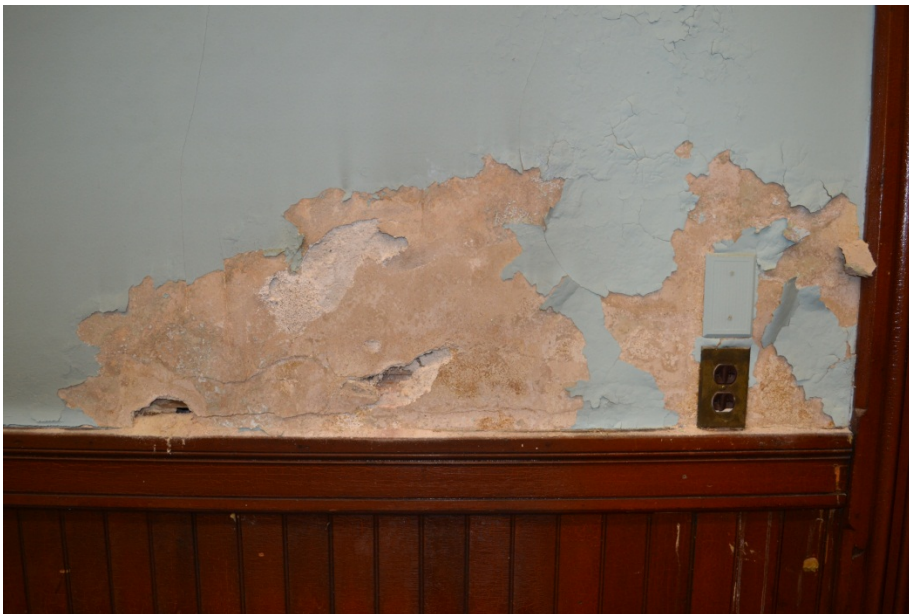
The original plaster at the auditorium exterior walls is deteriorating most likely due to water infiltration and change in temperature from exterior to interior conditions. Most of the deterioration occurs at the chair rail elevation and at radiator locations. Deteriorating plaster also exists at exterior wall behind the wood veneer board at southeast corner stairway.

Deteriorating plaster on lath at west auditorium wall.

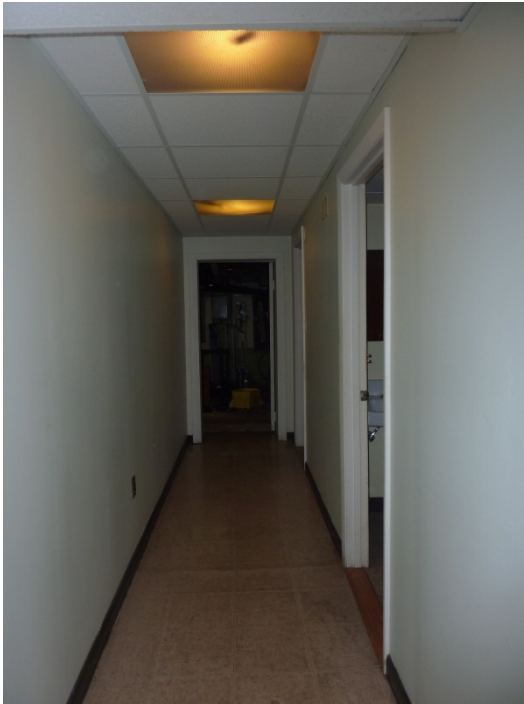
The basement vinyl tile in the offices and restrooms is in poor condition. The raised wood floor is settling and constant wear is causing the tile to crack and buckle. The carpet in the Council on Aging rooms is older and should be replaced. The rest of the storage areas in the basement have unfinished floors.

Vinyl tile in hallway at restrooms.

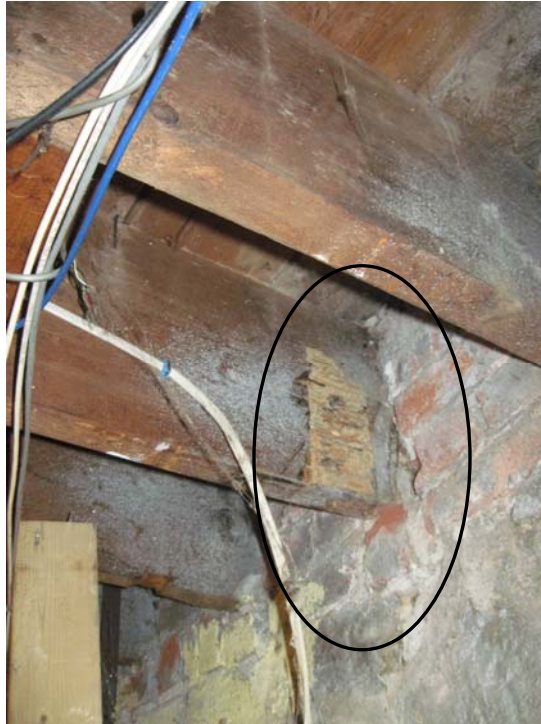
Figure 2: First Floor Joist End Deterioration at Exterior Wall

covered with finishes, but at the few locations that were exposed to view, we noticed the wood framing was in generally good condition. In the basement area, we did notice several joist ends that were damaged by dry rot or insect damage (see Figure 2), typically near exterior walls where the wood was built into the brick masonry. These joists should be repaired during the renovation by either replacing the joist or sistering new members to the damaged member. Also, since the entire building appears to be built with the wood framing sitting on exterior masonry walls, it should be expected that additional damaged joist ends may be uncovered during renovation work.

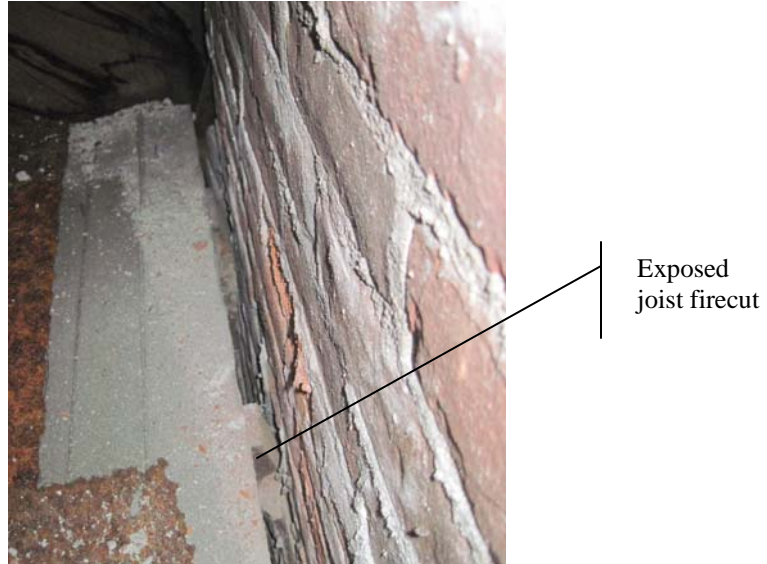
Figure 3: Attic Floor Joists at Front Gable Wall

The attic is framed using the bottom chord of the three main roof trusses, as well as some additional interior framing. During our walk through, we noticed several items in the attic that should be corrected during the renovation. The first is the attic floor joist framing appears to have pulled away from the front gable wall by approximately 1½" (see Figure 3). The floor joists were installed in masonry pockets with a fire cut, and the fire cut is nearly fully exposed, leaving the joist bearing to a minimum. We would recommend installing a new ledger below the joists and re-connecting the floor to the exterior wall.

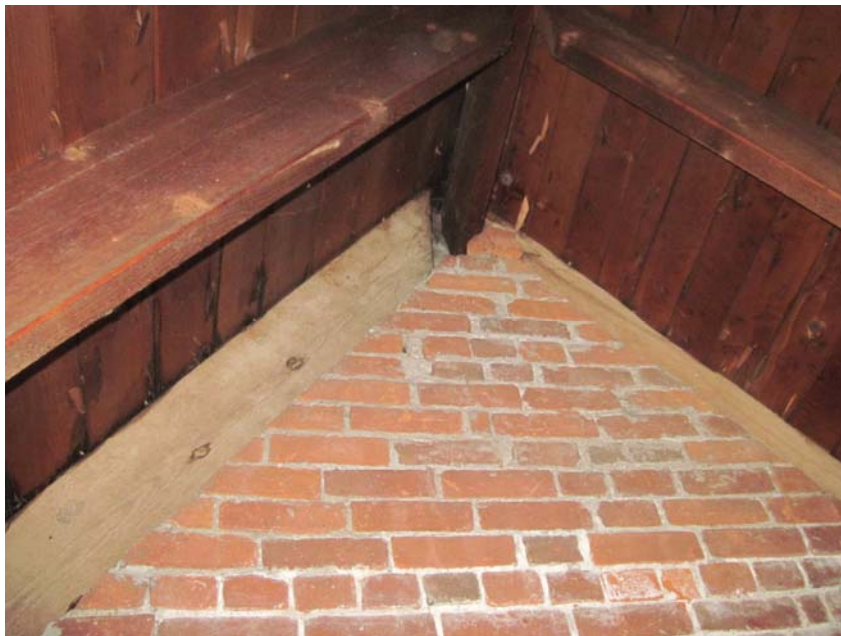
Figure 4: Ridge at Gable Wall

At the front gable wall, the brick masonry backup extends to the underside of the sloped roof framing. The roof rafters have pulled away from the ridge and require repair work to reconnect the members. Also, there are no noticeable connections from the wood framing to the masonry wall (see Figure 4). It appears that the wood framing was built onto the masonry. In order to conform to IEBC renovation requirements, the attic floor and gable wall will need to be adequately connected to the exterior masonry walls to reduce seismic hazards of the building. We would also recommend bracing the tops of the trusses since they appear to have moved laterally over time due to wood creep and lack of bracing to a proper diaphragm.

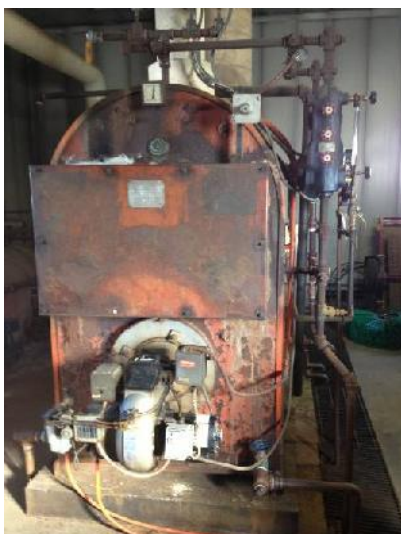
Figure 1 – Existing Boiler

The heating system has outlived its useful life and does not perform well. This should be replaced with a system that allows for more zones and for proper ventilation.
