DATE: December 22, 2022 (Revised)

FROM: Joseph J. Weismann, CHP
Director, Radiological Programs

RE: AFTER ACTION SPILL REPORT – Grafton & Upton Railroad for Nuclear Metals
Project

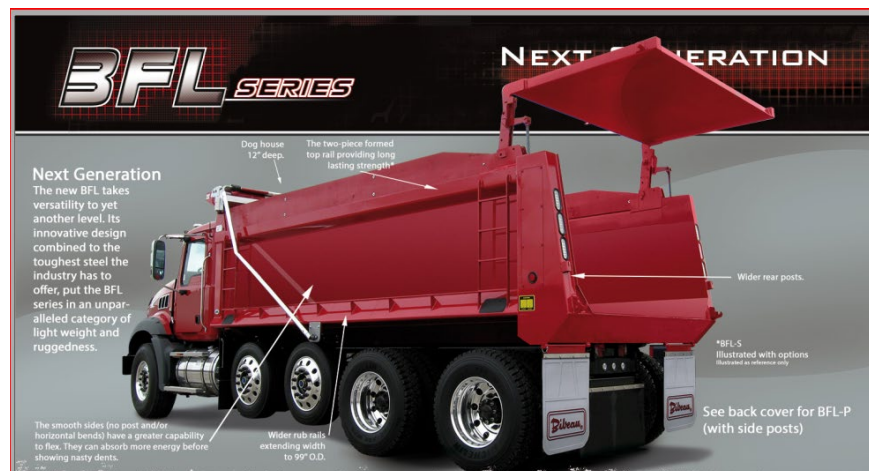
Figure 1. Tri-axle Truck with dump bed and hydraulic tailgate option

- One observed difference with the trucks in use at NMI (versus other types used previously) is the presence of a hydraulic top-hinged gravity opening tailgate. The hydraulic capability allows the tailgate to be fully raised prior to waste offloading (see Figure 1). Standard end-dump truck configurations are equipped with a manual top-hinged tailgate that once unlocked, swings open with gravity as the bed was raised. Project staff believe that not having the 'manual' hinged tailgate available during transload removes inertia introduced by the weight of the manual tailgate while the liner was being offloaded. This inertia aids in slowing the speed of the offload while the bed is being raised. We believe having the hydraulic tailgate fully open during off-load allows the waste to exit the truck at a faster rate, which in turn can lead to higher impact forces when the liner reaches the side and bottom surfaces of the gondola railcar.

- The hydraulic lift on the rear gate of the 'new' dump trucks was disabled. As described above, allowing the rear tailgates to open manually as the beds are raised is advantageous as it slows the overall transload. Although this change has likely brought incremental improvement, it was not found to solve the primary root cause of the liner failures.

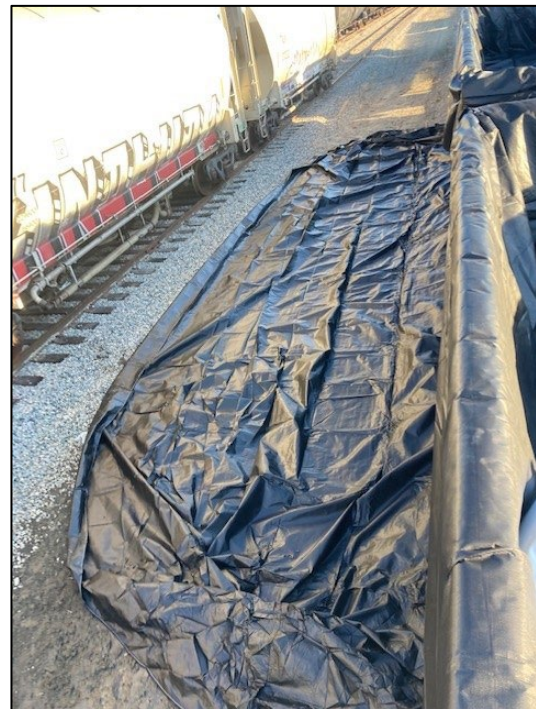
Figure 2. Photo of plastic sheeting used as intermediate barrier at the G&U Railyard

- Beginning on Tuesday, 11/22/22, plastic sheeting was installed on the ground behind the railcars to act as an intermediate barrier to contain any inadvertent spoils that may have escaped the railcar during transload activities. A photo of the plastic sheeting installed on 11/22/22 is provided below.

- Plastic sheeting has been placed on the railbed surface adjacent to the gondola railcars being loaded to collect any future spills until the liner integrity issues have been resolved. This plastic will support easy collection and reloading of any spoils back into the railcar and mitigate the need for future remediation crew deployments.

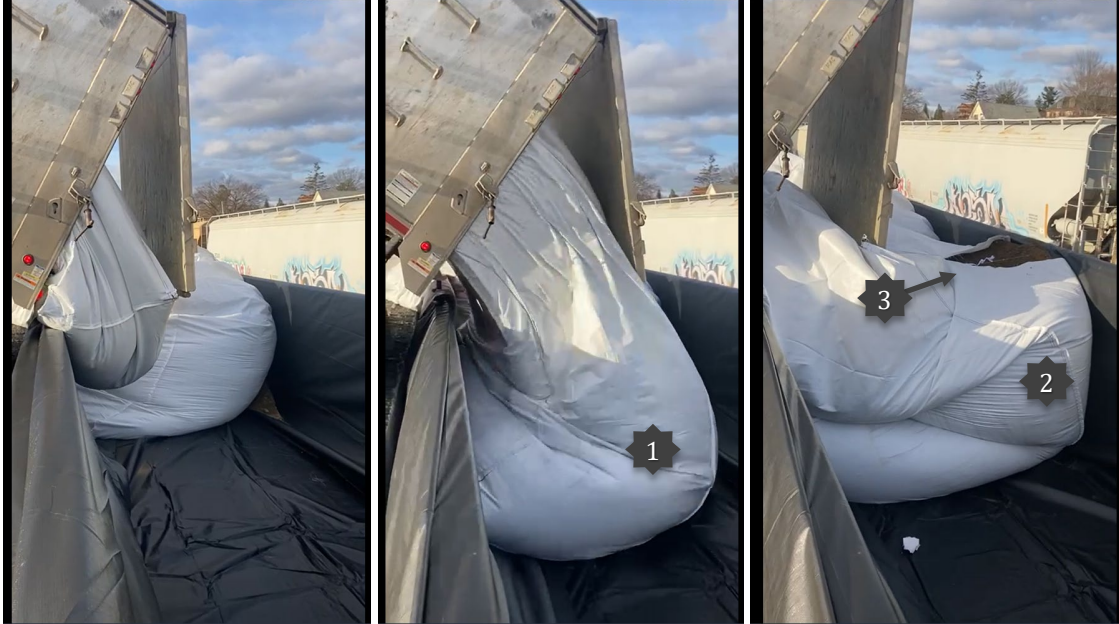
Truck #1 – Liner Failure During Trans-Load

Initial Waste Offload - Liner and waste begin to exit truck as bed is raised. No issues observed at this point.

Primary waste transfer - As liner and waste touches bottom of the railcar, liner begins rolling over onto itself. See Note 1 in photo. This crease captures the liner and does not allow movement as waste is being dumped.

Final Waste Transfer – Crease from fold-over is more pronounced (Note 2), causing additional stresses on fabric seams and closures from pressure build-up within liner. Liner fails at the rear wall of the railcar (Note 3).

1. Liners being subjected to stresses beyond their designed engineering limits. If a liner rolls upon itself during off-load, it can lead to binding and pressure build-up within the liner that exceeds the tensile strength of the fabric or supplied closures.
2. The project team also believes that the height of the trans-load ramp may be contributing to the frequency of these failures. At present, the bottom of the dump bed is approximately 10-12” above the wall of the gondola railcars (see adjacent photo). The project team is of the opinion that this additional height leads to the bags exiting the truck at a faster pace, leading to additional stresses on the liners.

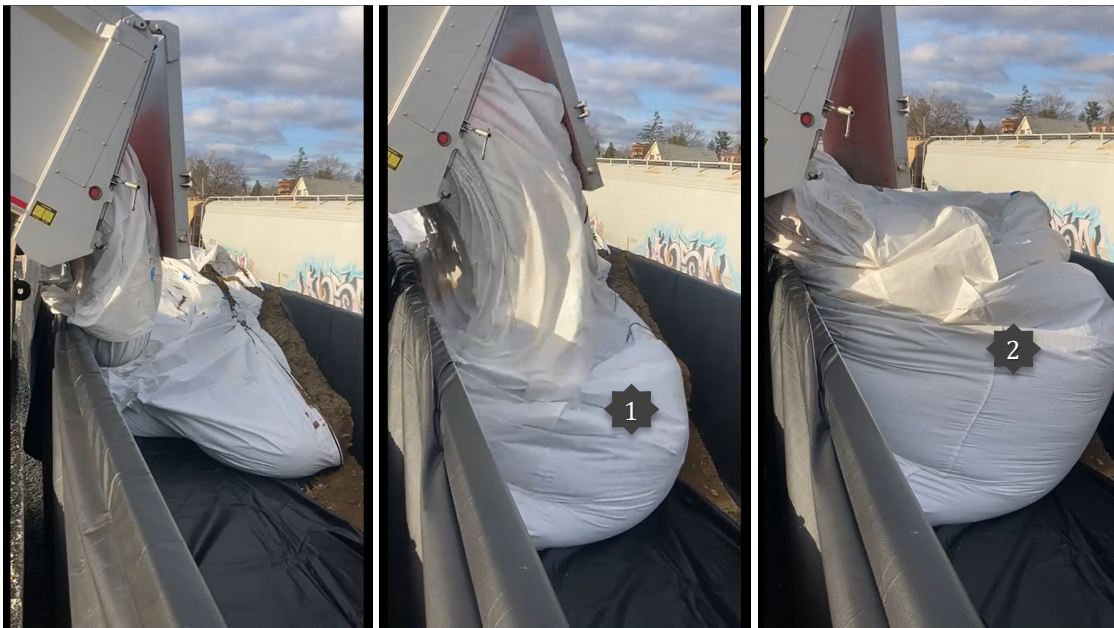
Truck #2 – Successful Trans-load with no liner failure

Initial Waste Offload - Liner and waste begin to exit truck as bed is raised. No issues observed at this point.

Primary waste transfer - As liner and waste touches bottom of the railcar, liner position is stable and waste accumulates evenly within liner and railcar as it is dumped from truck. See Note 1.

Final Waste Transfer – Even waste distribution continues and liner flexes as designed (Note 2) within the width of the railcar. Liner integrity remains intact through final transfer.

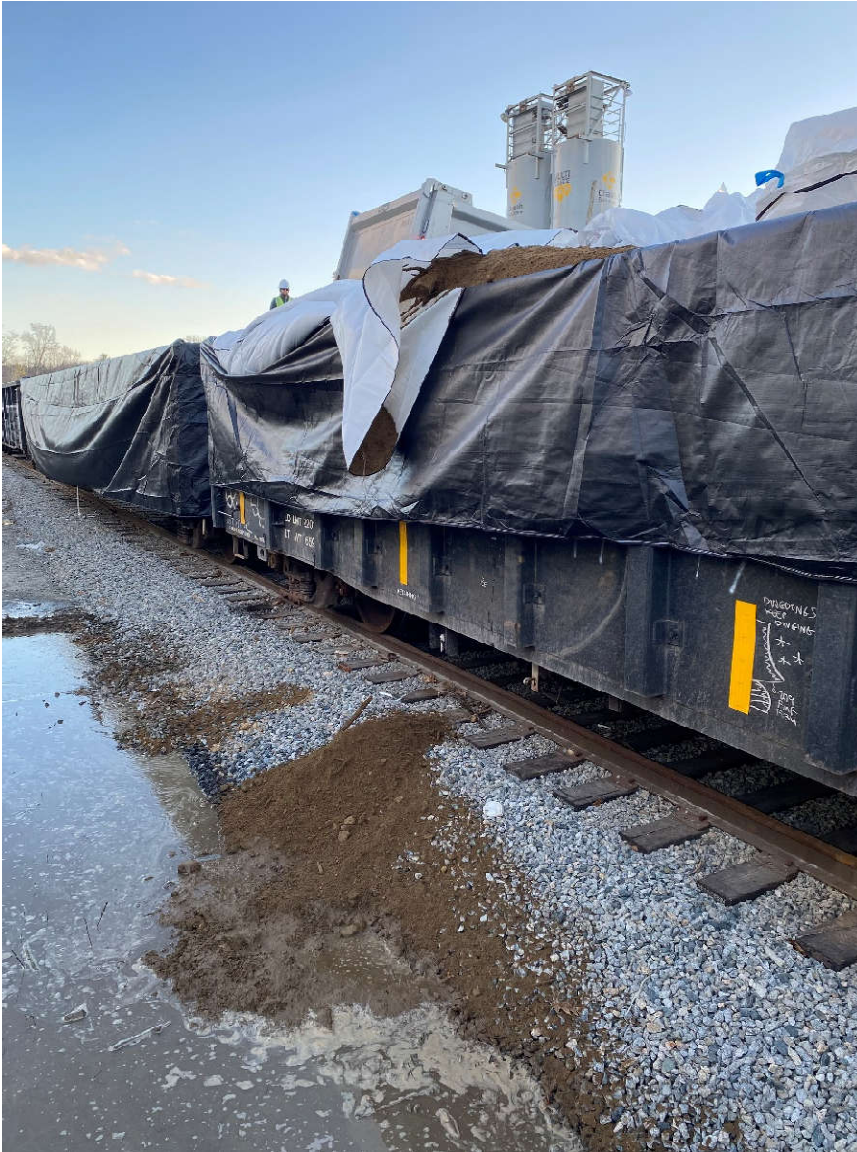
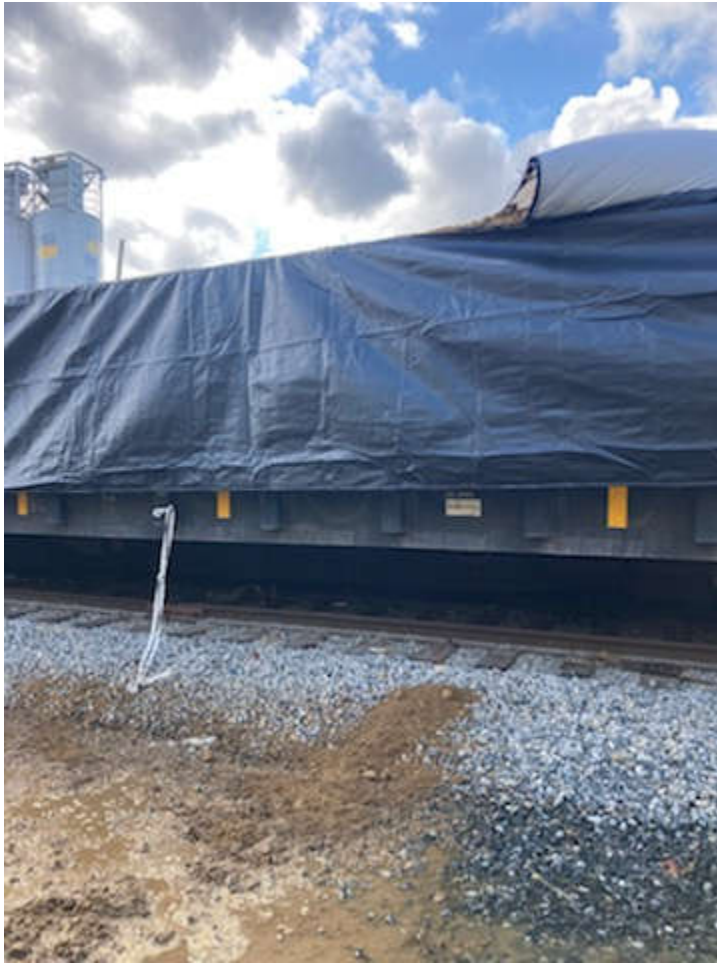
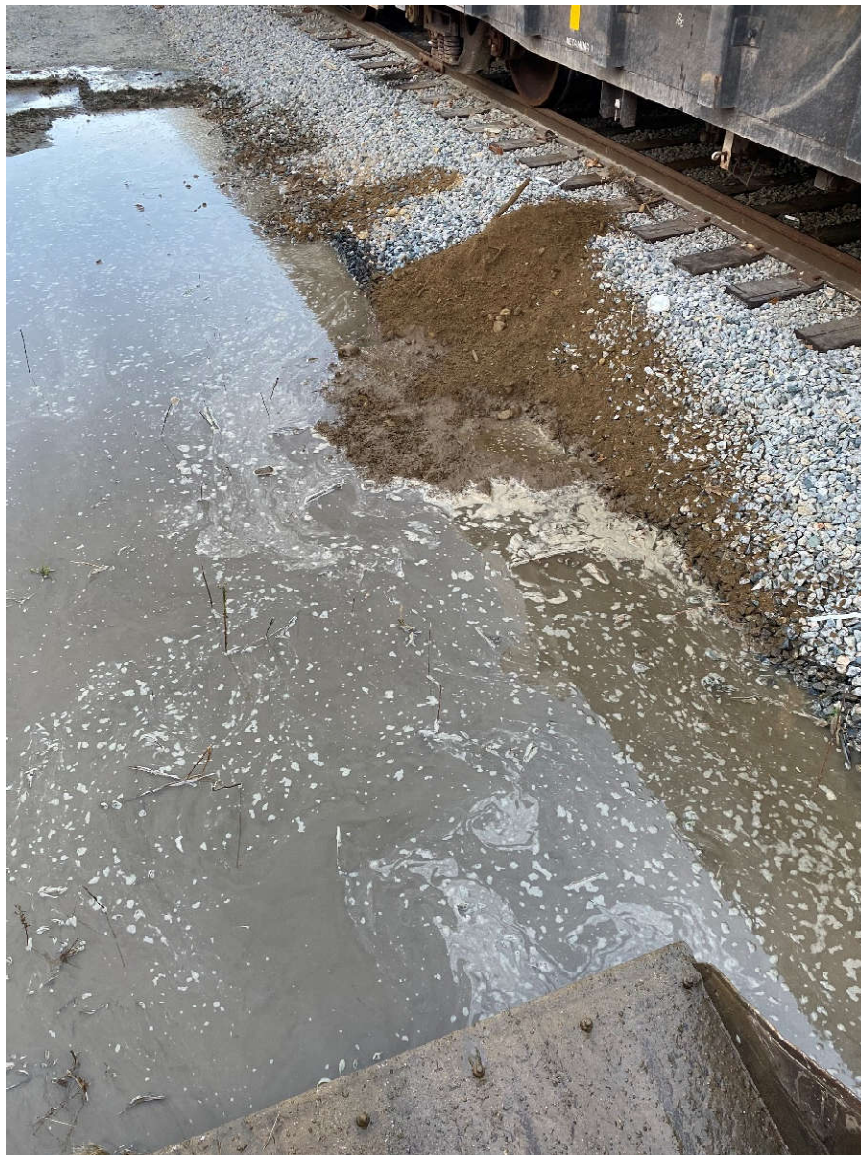
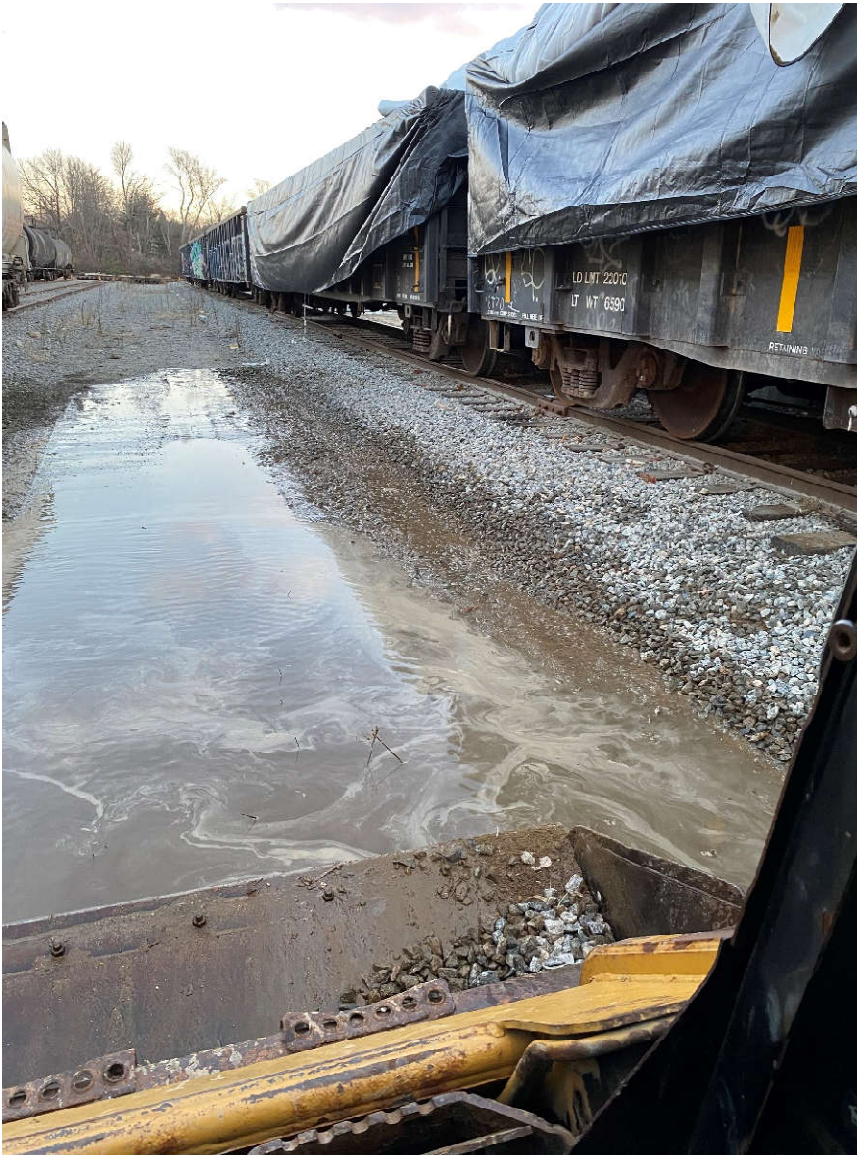
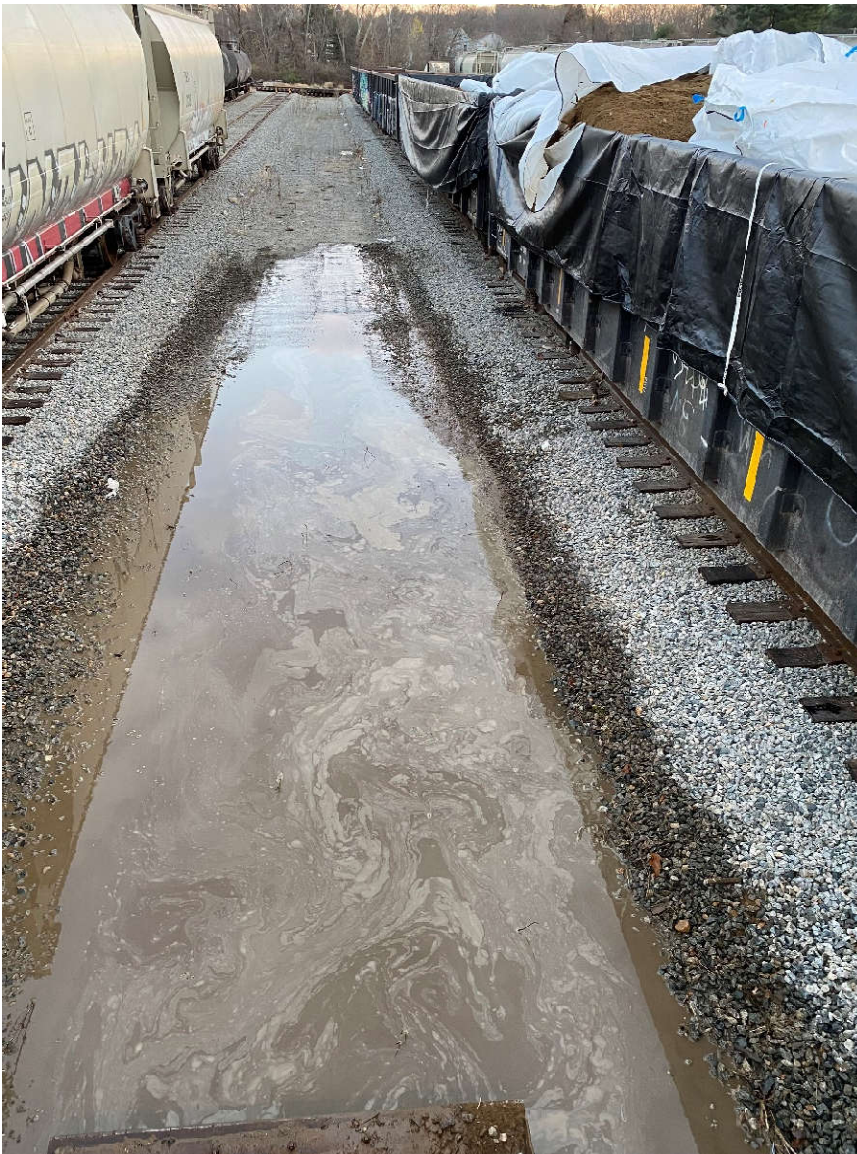
Pictures

USE Franklin was called about soil bags breaking while offloading into railcars at the Hopedale Railyard. A crew was dispatched to remove soil from railyard ballast on opposite side of railcar ramp. Operator and tech mobilized with skid steer to clean up soil. 2 bags broke while being offloaded from triaxles into railcars. While the operator was cleaning up soil, he witnessed two more bags break from 2 separate offloads out of triaxles and spill soil into the same area. A total of 4 bags broke. Operator and tech completed clean up and loaded all soil back into rail cans. Checked with railyard attendant and according to operator he was satisfied with response.
