Hopedale Town Hall Renovation Project

Building Conditions Assessment and Recommendations Report

Bargmann Hendrie + Archetype, Inc.
Boston, Massachusetts

for
Town of Hopedale, Massachusetts
January 2013

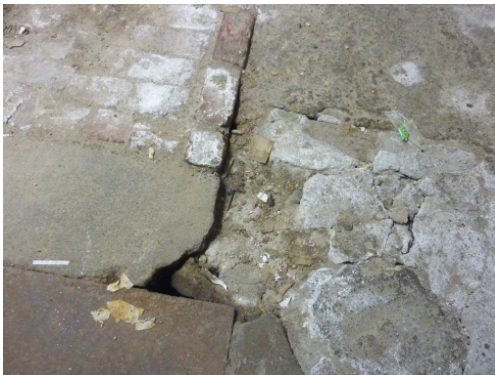
Original concrete, brick, and stone floor in center storage area of basement.

Remove the added subfloor in the northwest and northeast areas of the basement if these areas are to be used for program space or public access. Provide a new floor structure that allows for code-compliant bottom stair risers should be provided. The best way to do this is by removing the rubble concrete and providing a new concrete slab with vapor barrier, then a new finish. Some sort of leveling finish could be considered, but given the existing concrete conditions and extent of existing trenching and likely underslab pipe work, this does not appear to be the most suitable option.

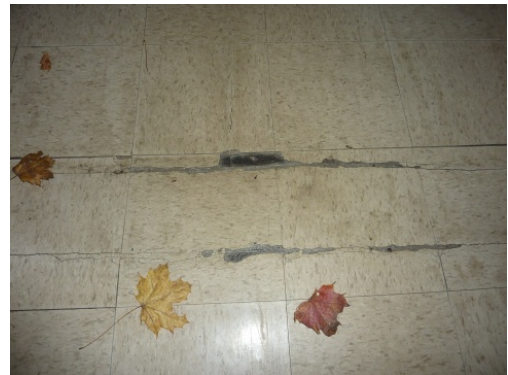
The Health and Building Department office and restrooms sit on a subfloor 4-1/2" above the original floor. This floor is built of wood 2x4 framing, a sheathing layer, and vinyl tile floor covering. The subfloor steps back down to the rubble floor at the doorway into the center storage room. Movement of the subfloor is visible in the cracks in the vinyl tile in the hallways and building department office. A grate is located in the floor in the closet of the Health department office. Referenced from the Indoor Air Quality Assessment in June of 2000, a trough in the floor beneath the Health department office had water running through it. This area needs to be examined more closely when the subfloor is removed.

Vinyl tile on wood framing in offices and restroom

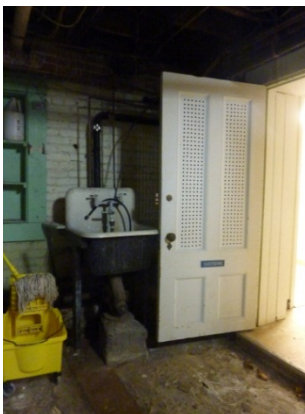
Step down into original level of basement at doorway from offices and restroom into center storage area.

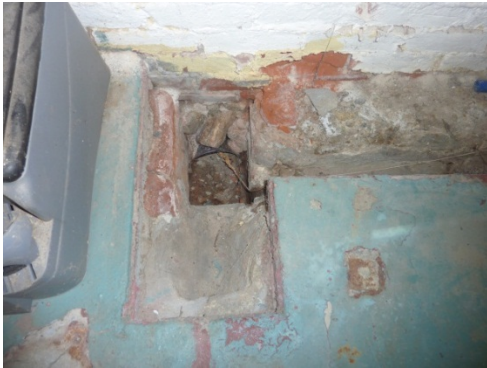
Trough at northeast storage floor.

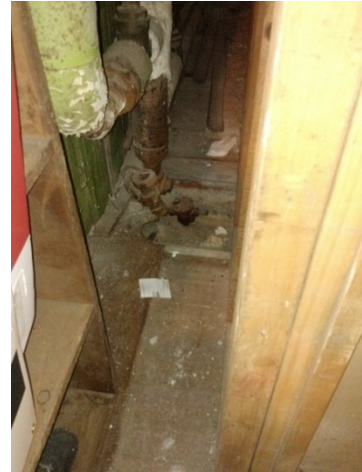
Steam pipe and grate at floor behind north wall in Board of Health office.

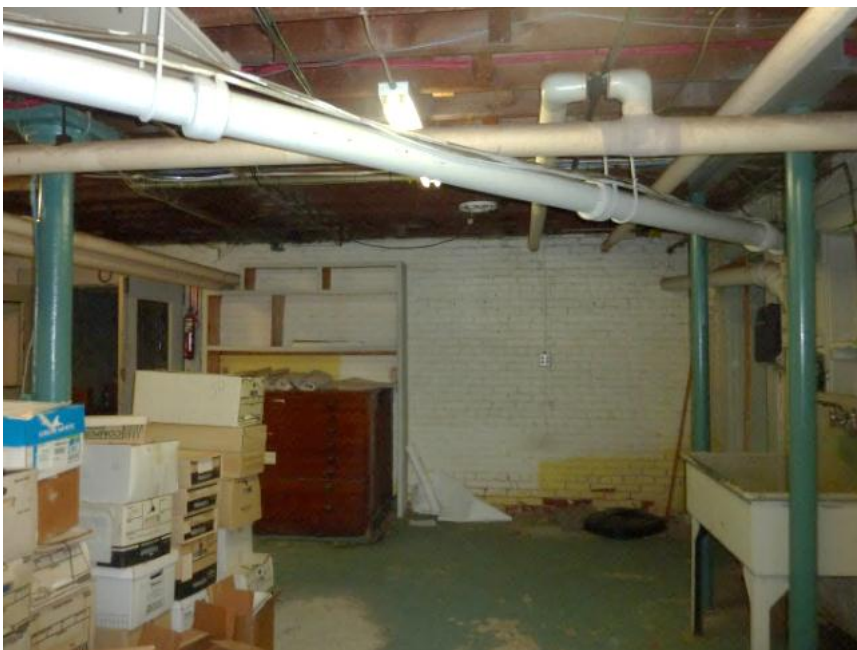
The interior bearing walls are constructed of unreinforced brick and are painted. These walls are in good to fair condition overall, but the base of the south and west walls of the northeast storage room and the west wall of the center storage room have missing mortar and spalling brick due to moisture damage. Cased window openings in some of the interior bearing walls, basement exterior storefront windows, and original toilet rooms are indications that at least some of the basement was originally used as occupied space.

Brick load-bearing interior partition wall in northeast storage room.

Once finishes can be removed, inspect for additional moisture damage and repair.
Remove spalled brick at wall bases, and repoint mortar where deteriorated.

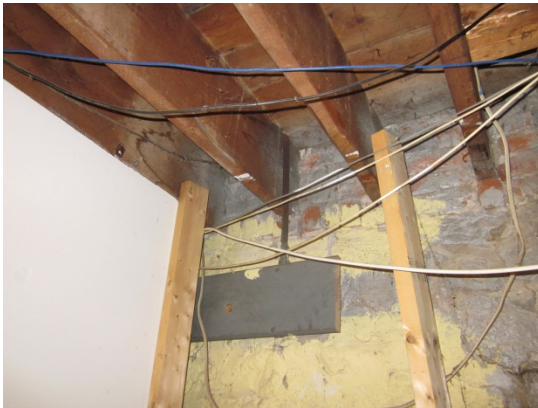
The wood joists are 10-3/4" deep. The wood joists are imbedded in the brick exterior wall and have a header course of brick under them for added support. An opening in the floor (seen from the basement) indicates that a wood stair running from the first floor to the basement was located under the southeast stair in the present Town Administrator's office.

Wood first floor joists at exterior wall.

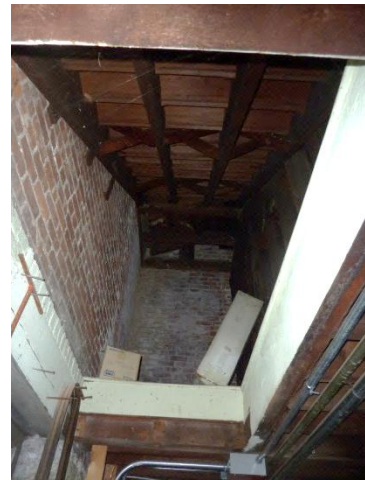
Location of a former stair to the basement.

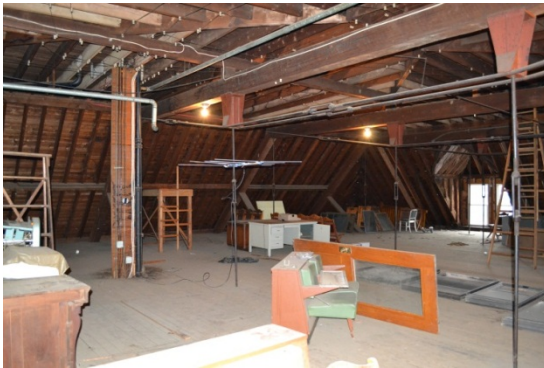
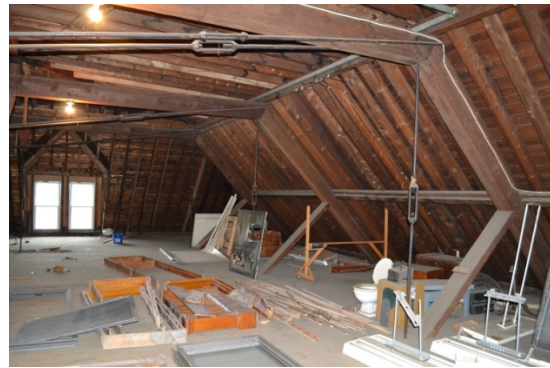
The mansard roof framing is exposed in the large attic on the third floor. There is water damage present at the valley between the south dormer roof and mansard roof and also at the center of the flat roof and access hatch. It is unknown if the water stains on the wood are from active leaks.

View of attic, roof framing and south dormers.

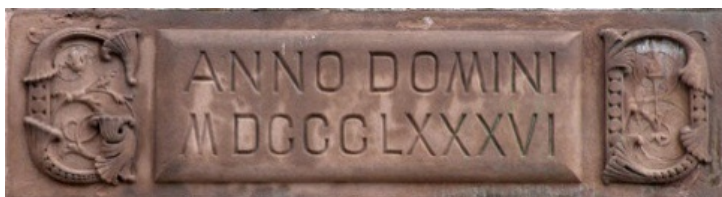
There are many intricate carvings in the pink granite stone including one in the front of the building with the year the building was built, 1886 AD, and the initials of George Draper, the donor of the building (Anno Domini, MDCCCLXXXVI). These are all in good condition, except for the carvings on the north transoms that have black staining.

Stone carving at north wall.

Use a stain remover to remove rust and other stains on the stones.

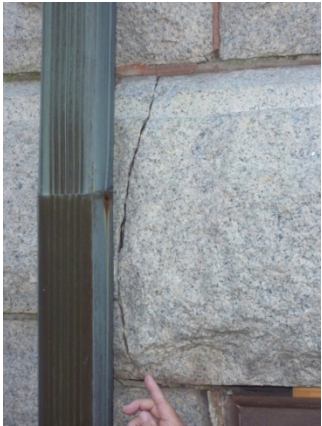
Large crack in granite above storefront window in basement

Remove interior finishes to better determine the reason for the large crack in the granite stone, whether it was from rusting tie rods, shifting structure, or failed lintel support.

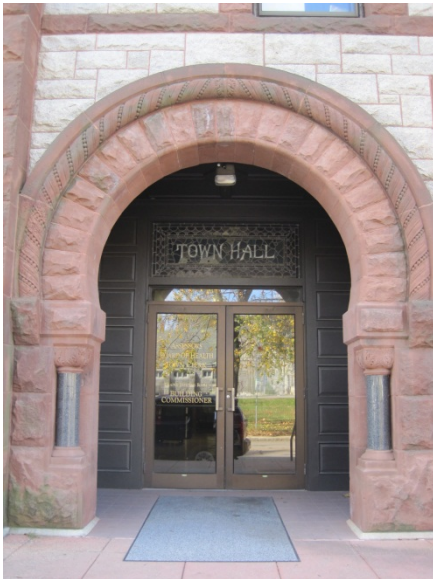
All of the exterior doors on the building are replacements rather than the original wood doors, and therefore are not character defining features of the building. The aluminum northwest entrance double doors are wide enough and swing in the correct direction for code compliance, but are not air tight and actually swing open when the wind blows. The weatherproofing is inadequate and leaves a gap between the doors, making the entrance vestibule very drafty.

Exterior doors at main entry.

Replace all doors with new code compliant doors and thresholds to prevent air infiltration.

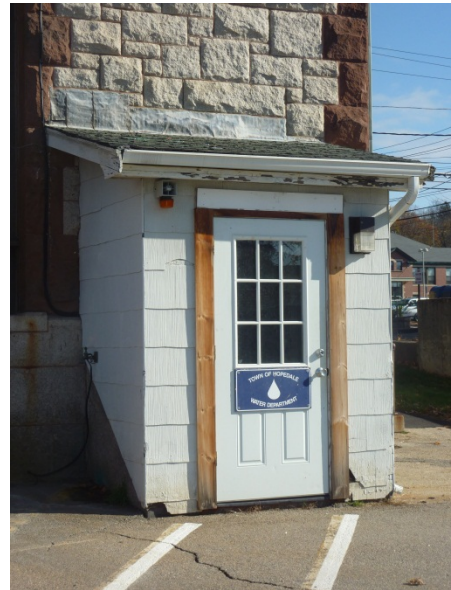
The south exterior basement entrance shed is in fair condition, but does not match the aesthetic of the Town Hall building.

Exterior door at south basement entrance.

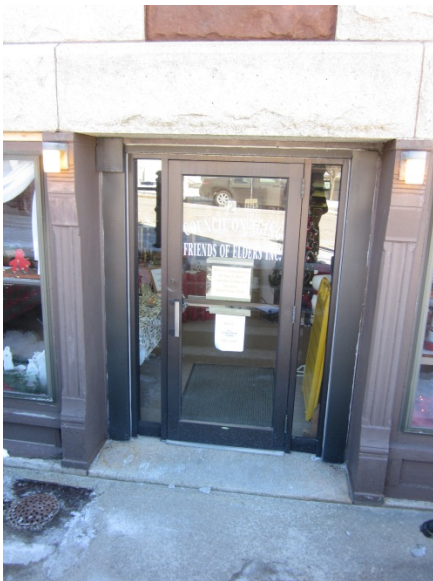
Exterior storefront door at Council on Aging.

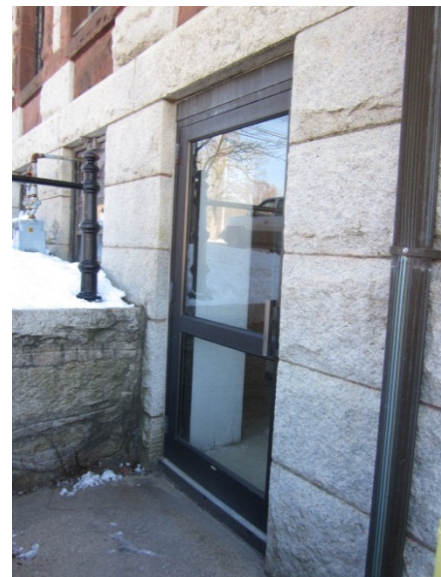
Exterior door at basement office area.

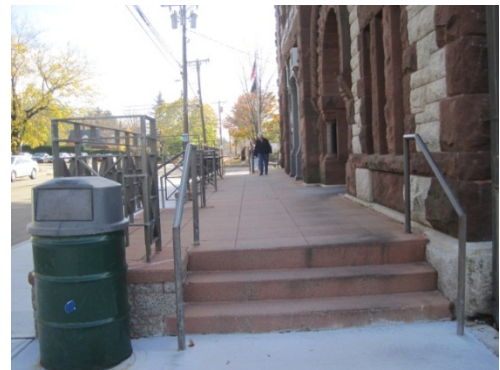
Stair at west elevation

At the west elevation, the sunken entrance areaway has stairs to access the basement and Council on Aging doors. The granite stair has irregular riser heights and irregular tread depths, causing this stair to not meet IBC 2009 code. The cast iron handrails do not have handrail extensions and should be replaced.

Retain existing stairs and ramp at main north entrance platform.
Provide new stair handrails and ramp handrails at north elevation.
The new options for reuse will determine if the existing concrete steps at east elevation will be retained or demolished.
Remove rusting metal fire escape at south elevation.
Depending on new options, provide accessible entrance and new stairs and handrails to west basement areaway.

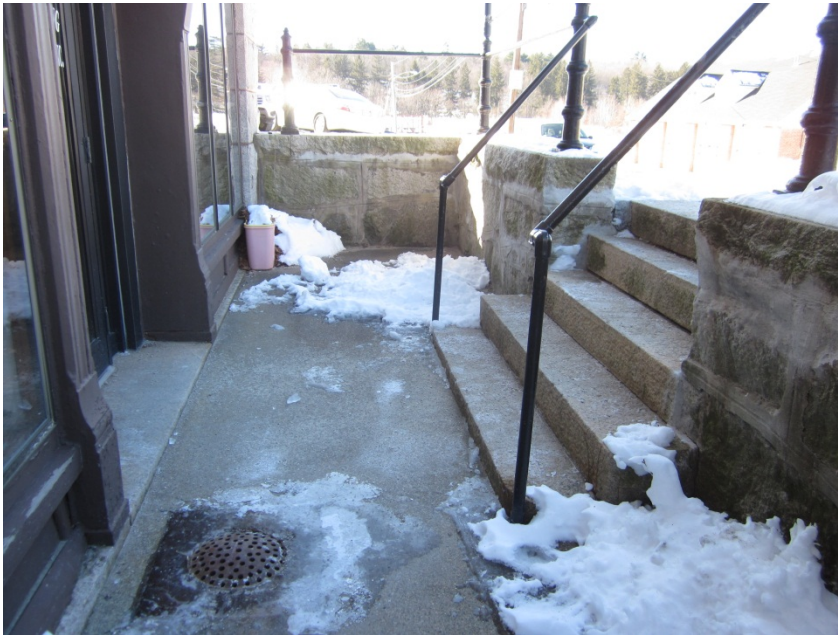
West basement entrance to the Council on Aging Shop.

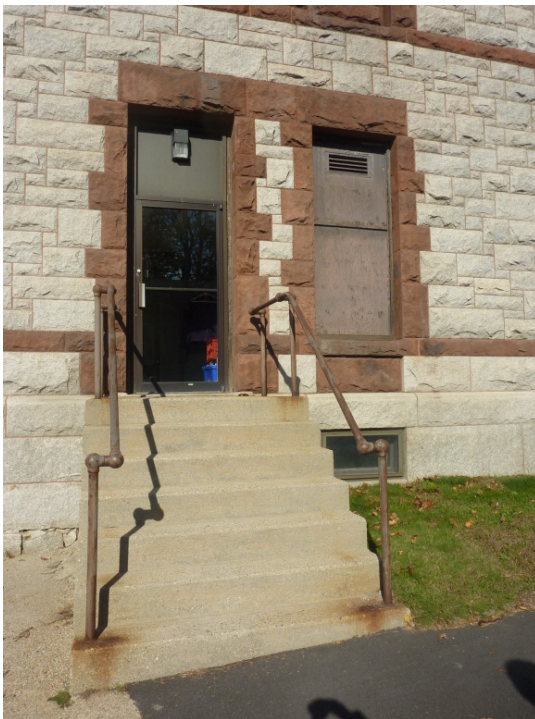
The concrete stairs at the east elevation are in good condition, except for some rust staining near the handrail posts. The landing at grade is sloped, causing the last riser to differ in height from one side to the other. This condition is not code compliant and will need a flat landing. Because the stair is more than 30" above grade, it will need guardrails as well as code compliant handrails.

Concrete stairs at east elevation.

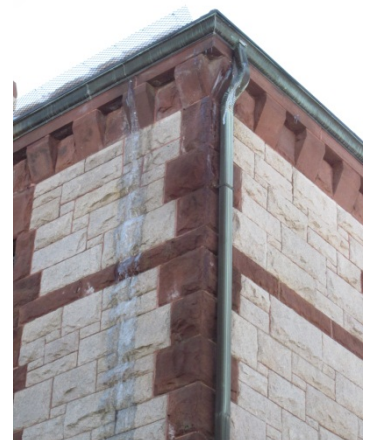
The copper gutters are severely worn in several locations, with open holes that allow water to pour out. Gutters are also deteriorating at the downspout connections and causing water to leak out of the seams instead of flowing into the

downspouts. Water is finding its way between the gutter and the brownstone, and is flowing out of the bottom of the gutter. This was particularly evident after a heavy snow, when a stream of water froze at the face of the building at the west end of the street façade. The leaks at the gutter system have resulted in staining and efflorescence at the brownstone cornice. While no spalling is yet evident, allowing this gutter condition to remain will lead to deterioration of the brownstone.

Water pouring under gutter at north elevation.

Replace elbows at downspouts. The remainder of copper leaders could be retained.

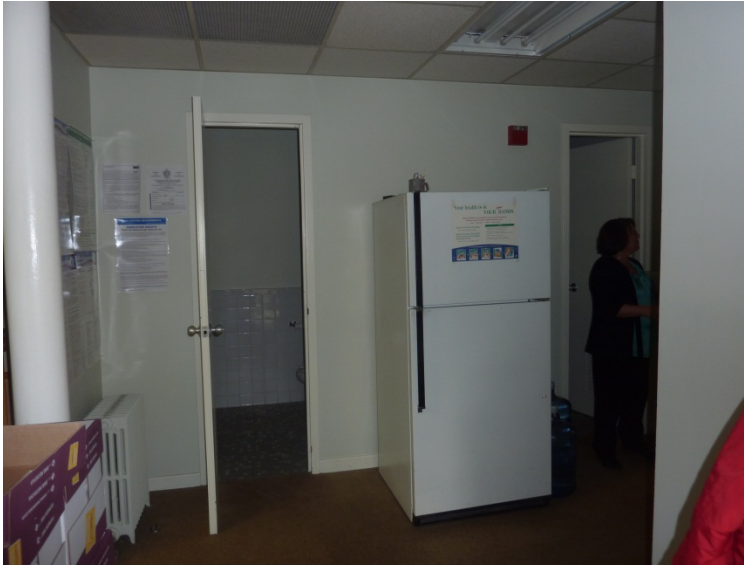
There are some code issues relating to the doors, including door width, clearances, and hardware. While many of the (assumed) original paneled wood doors are wider than average, some of the modern doors do not meet the minimum clearance needed to meet MAAB standards. All door openings into rooms need to be at least 32" clear. The door from the Selectmen's meeting room to the general office and the door from the Town Administrator area to the general office are only 30" clear. The toilet room doors on the first floor are only 24" clear and do not meet requirements. The cast iron column outside of the Town Administrator's office door is blocking the 12" clearance space needed at the latch side of the door. Another clearance issue is the door at the stair behind the stage on the second floor does not clear the radiator when fully open. Many doors have decorative knob hardware that does not comply with accessibility requirements.

Doors to bathrooms do not meet minimum MAAB clearances

- Replace missing transoms with new transoms to match original.
- Replace older auditorium double doors with higher quality wood doors and new hardware.
- Modify wood and concrete thresholds to be no higher than 1/2".
- Remove radiator from auditorium to provide clearance for door swing.
- Relocate the Town Administrator's office door to meet door clearance requirements from MAAB.
- Provide new lever handle hardware where doors are to remain but hardware is non-compliant.

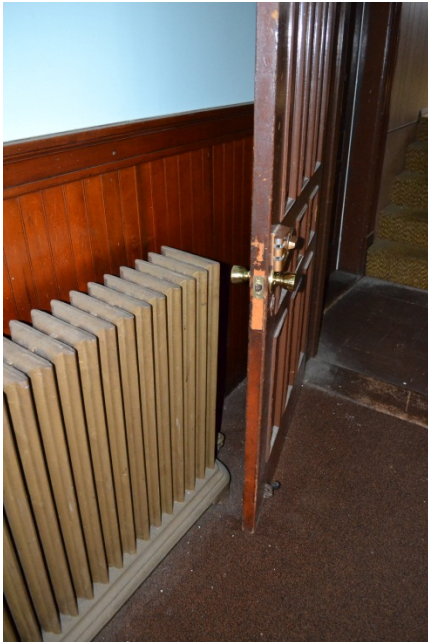
Door to backstage hits existing radiator when open

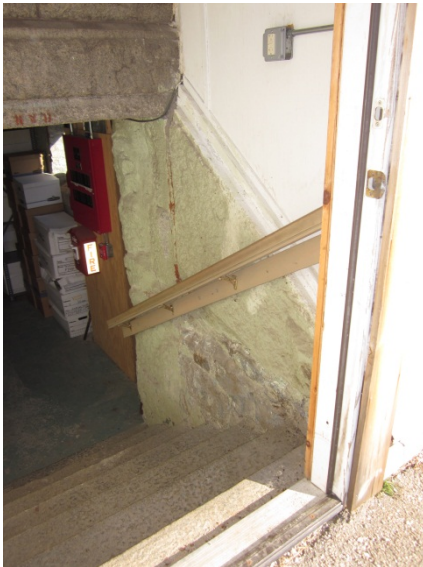
The second egress stair out of the basement is located at the southeast corner of the building. This concrete stair exits to grade at the rear of the building. The top stair is obstructed by the threshold of the shed door and the bottom riser at the basement level is 5" tall while the other risers are 8" tall, because of the slab poured over the existing basement.

Stair to basement from parking lot.

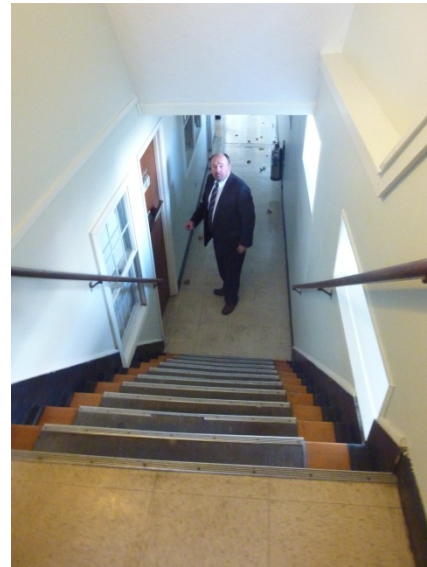
The main basement access is from a stairway located under the grand northwest stair. This stair is wood, with the same non-slip material and metal nosing as the northwest stair above. The risers are at differing heights; most of them are 8", but the first few, starting at the first floor, are 7", 7-1/4", and 6-3/4". The last riser at the basement level is 5" high because of the raised subfloor at this level. This stair and handrail are not code complaint.

Northwest stair from first floor to basement.

Remove vinyl tile from northwest stair landings. Sand and restore wood treads and risers if possible. (Wood treads might be worn or damaged. Allow for some replacement.) Provide non-slip material if wood is not suitably slip-resistant. Retain and restore existing baluster handrail at northwest stair, but add a code compliant guardrail and handrail. Add continuous handrail at walls of stair.

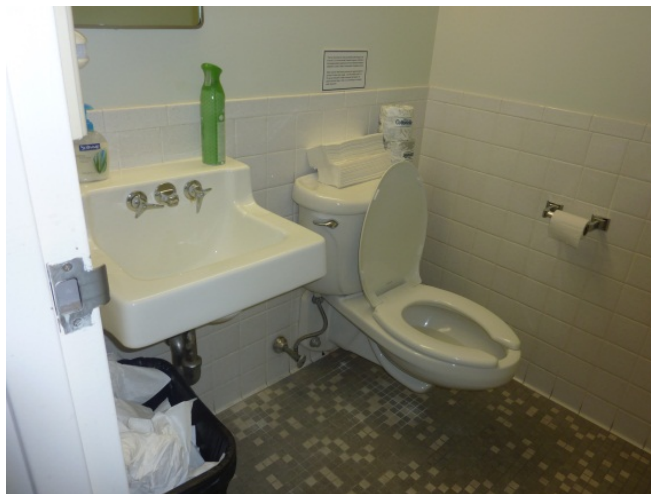
To comply with the plumbing code, the building does not need a restroom on all levels. Employees and the general public are able to go up or down one level to access a toilet room, but an accessible toilet needs to be located on an accessible level. Right now, there is an accessible toilet on an inaccessible level and an inaccessible toilet on an accessible level. Town Hall restrooms are undersized for the allowable occupancy of the building.

First floor inaccessible toilet room

Recommendations:
Reconfigure restrooms to be accessible.
(See plumbing section for comments on fixture condition.)

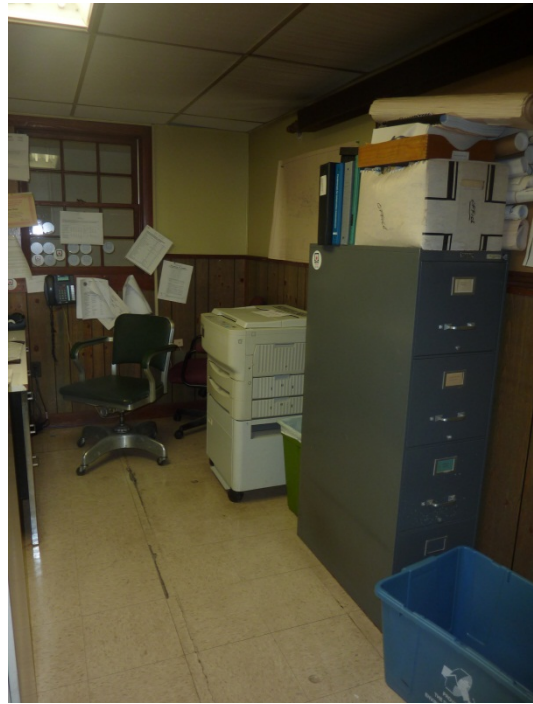
The basement vinyl tile in the offices and restrooms is in poor condition. The raised wood floor is settling and constant wear is causing the tile to crack and buckle. The carpet in the Council on Aging rooms is older and should be replaced. The rest of the storage areas in the basement have unfinished floors.

Vinyl tile chipping in Building Department office.

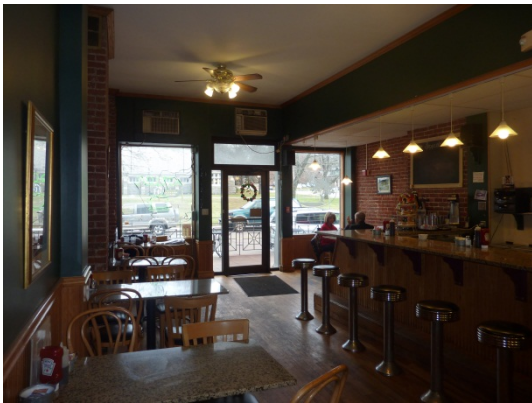
The café has exposed wood floors that are assumed not to be original because the floor level is higher than the door threshold level. There is a slight ramp up to the level of the café floor. The wood is worn and has lost its finish in high traffic areas. Vinyl tile is located behind the counter and in the kitchen. Vinyl tile is in poor condition and worn in many places.

Wood flooring at café

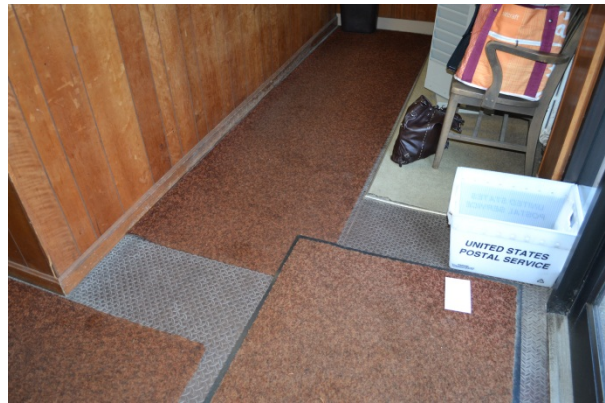
Rubber anti-slip flooring are installed at the reception area of the general offices. Walk-off mats are placed over the flooring to soak up water. The rest of the General Office area is covered in carpet.

Rubber flooring at reception desk at General Office

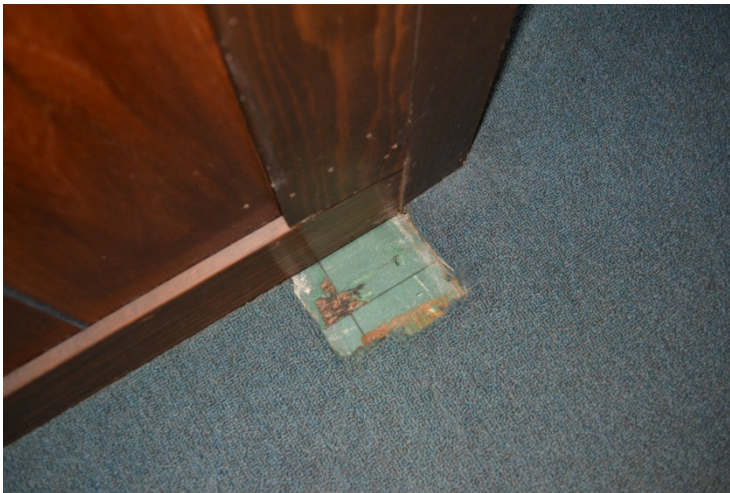
Vinyl tile found under carpet in Clerk's office

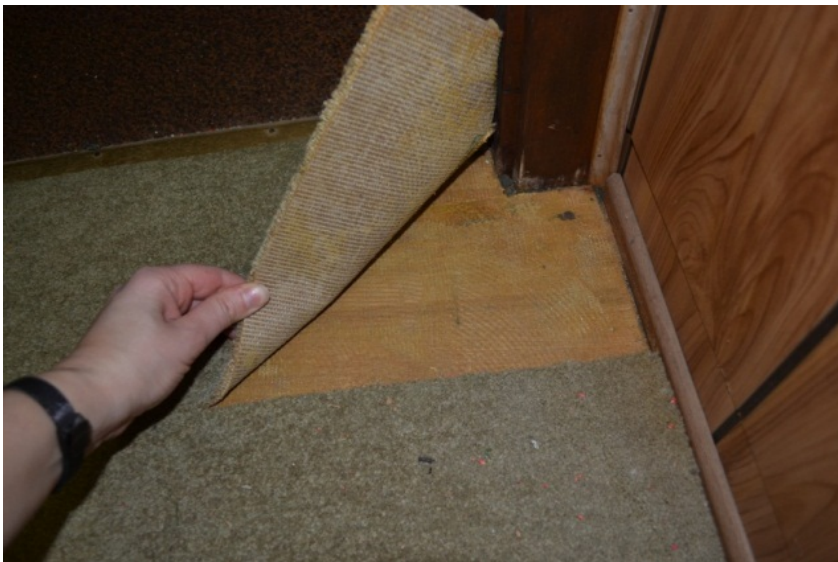
The auditorium, stage, and storage room behind stage (originally part of stage) has the original wood floors still in tact, but now covered with carpet. The Conference room, Assessor's rooms, and south storage room at the stage level, all have a layer of plywood under the carpet. It is not known if the original wood floor still exists in those rooms and, if it is, its condition is not known.

Plywood at floor under carpet at south storage room at stage level

Determine if wood floors are in a condition to be sanded and refinished in order to be left exposed.

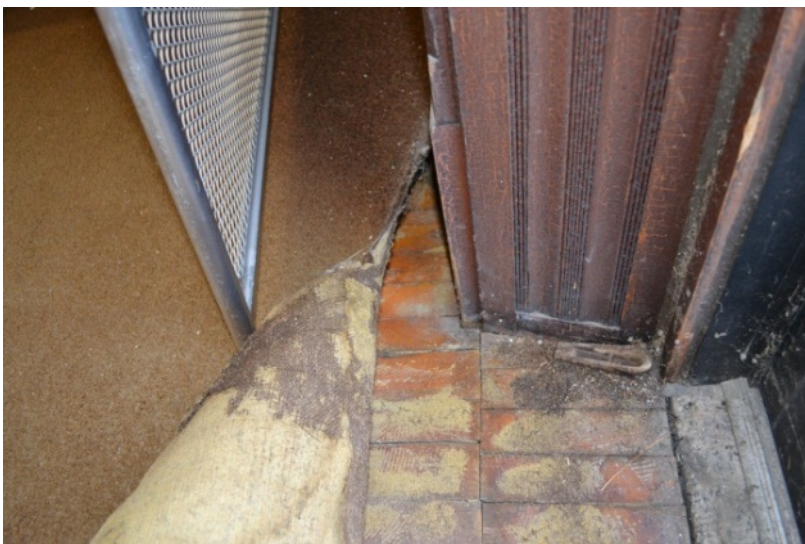
Wood flooring at auditorium under existing carpet

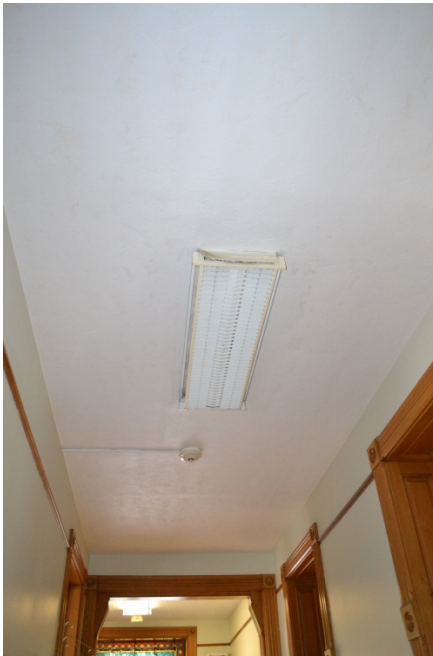
In most spaces, the original plaster ceilings are hidden with acoustical ceiling tile. It is unknown what condition the plaster is in on most ceilings. The textured plaster at the first floor hallway ceiling is not original to the building. The auditorium plaster ceiling is cracking and in poor condition.

Plaster ceiling at first floor hallway

Remove all acoustical ceiling tiles to expose plaster ceilings. Either provide new acoustical ceilings as part of renovation work, or repair plaster. The scope of work will need to take into consideration the addition of sprinklers and the replacement of other systems such as electrical, plumbing, etc., so it may be infeasible to retain original plaster ceilings.

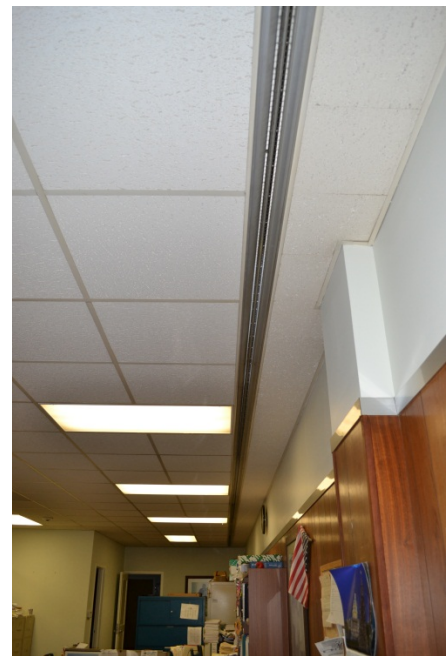
Acoustical ceiling tile at general office

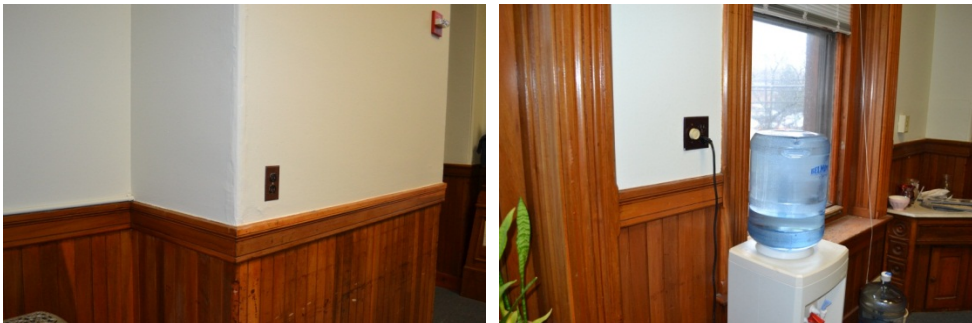
Lighting fixtures are functional but outdated. Branch wiring is a mix of old and new, including knob-and-tube wiring at the attic. Emergency lighting system is old and not functional.

Electrical at masonry wall in the second floor conference room

Replace branch wiring. Conceal wiring where possible, and consider aesthetically acceptable surface applied methods at masonry wall or other locations where finishes are recommended to remain.

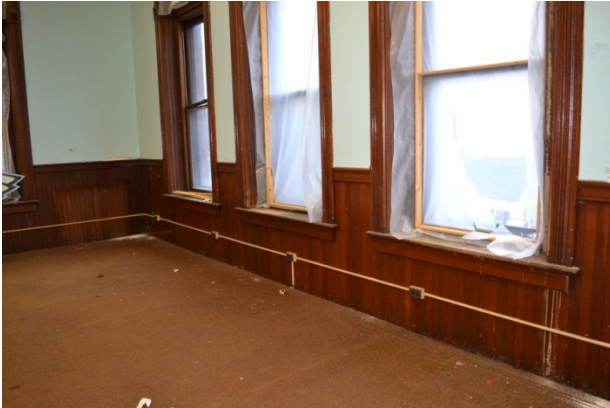
Electrical conduit at auditorium beadboard at exterior wall.

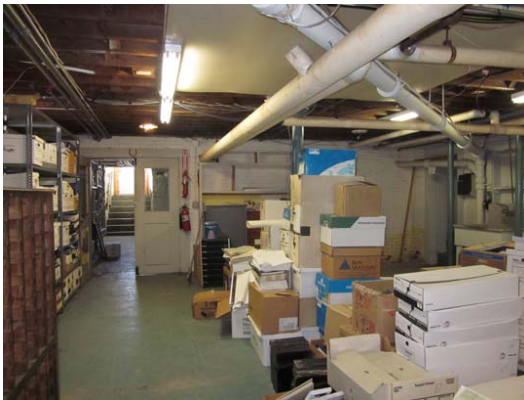
Asbestos was found in the window framing caulking, the vinyl floor tile at various locations, the paper under the hardwood floor at the attic, and various insulated pipes in the basement. While this material does not pose a problem if left undisturbed, the assumption is that the renovation project will involve removal of many of these components. All ACM (asbestos-containing material) must be removed by a Massachusetts licensed asbestos abatement contractor under the supervision of a Massachusetts licensed project monitor prior to any renovation or demolition activities.

Pipe insulation at basement

Incorporate hazardous materials abatement into construction documents for building renovation.

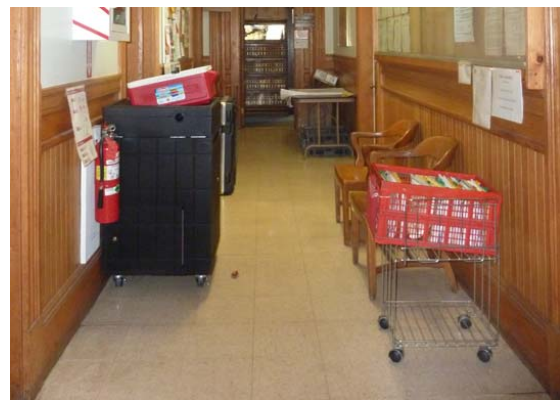
Vinyl flooring at first floor

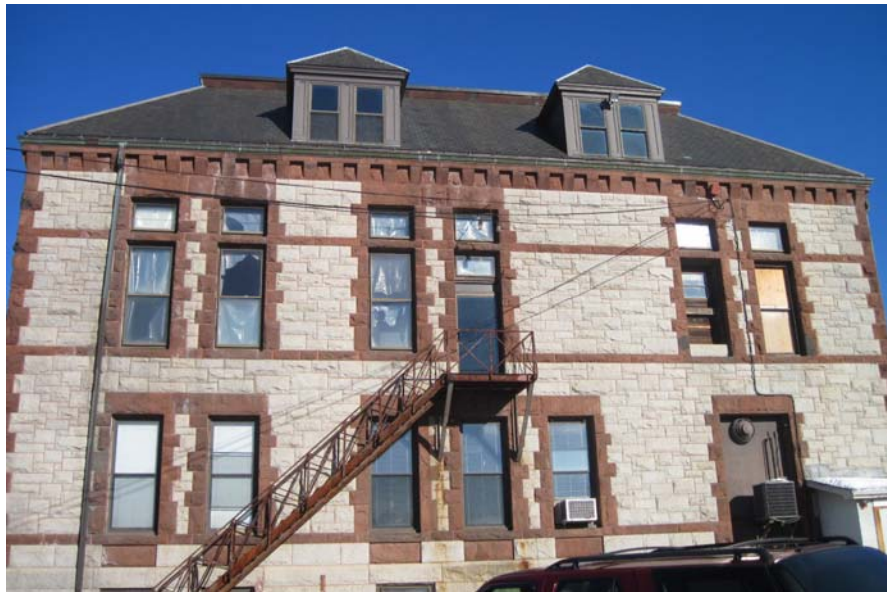
Figure 1: South Elevation

In general, the exterior walls of the building are granite and brownstone veneer backed up by unreinforced brick masonry (see Figure 1). The exterior walls bear on mortared stone foundation walls. The exterior stone veneer has been repointed and rebuilt at certain locations and requires regular maintenance. In general, the exterior veneer appears to be in good condition with minimal signs of settlement, but does require regular repointing and maintenance to limit water infiltration. There are several door openings that consist of stone lintels bearing on decorative cast iron posts. The cast iron requires regular maintenance and shows some signs of deterioration.

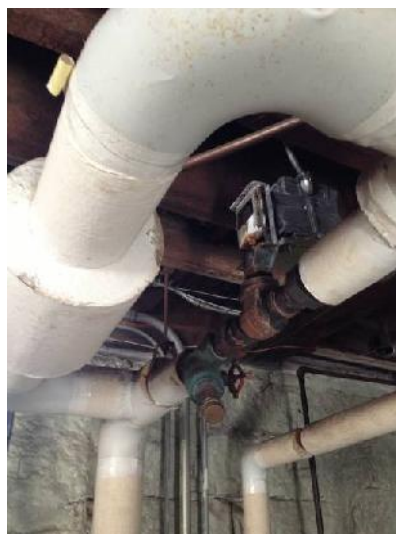
Figure 2- Heating Valve

The heat for the entire building is controlled by a single thermostat operated control valve located in the basement. The thermostat is located in the Selectman's meeting room. It is our understanding that the north side of the building does not maintain proper temperature and has had an additional valve installed in an attempt to improve the condition, which has not been effective.

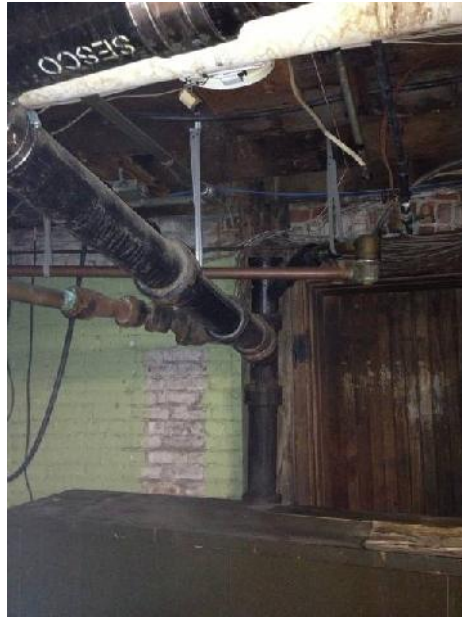
Figure 3 - Old & New Sanitary

The sanitary for the building discharges below the slab out the west (Depot Street) side of the building. The majority of the sanitary runs above the slab until it gets near the foundation wall. The invert of the sanitary pipe where it leave the building is unknown. The bathrooms located in the basement are built on platforms. It is possible that this was done because the sanitary pipe was not deep enough and the additional height was needed to discharge the sanitary by gravity. The piping is a mix of old and new with the majority of it being cast iron with lead and oakum joints. It appears that much of it is original to the building.

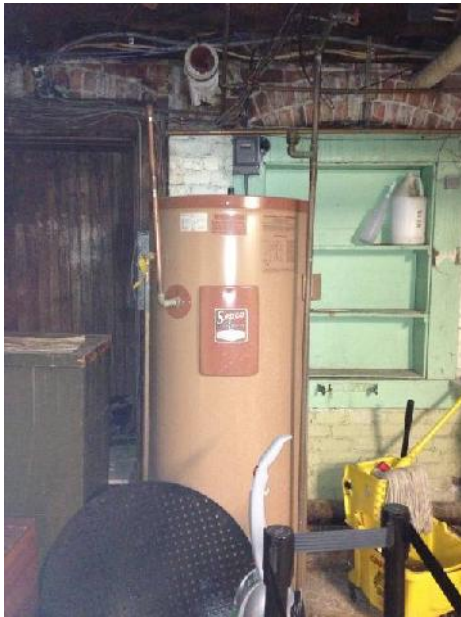
Figure 4 - Water Heater 1

There are two electric water heaters located in the basement. It is assumed that one serves the café and the other serves the town offices. One heater is 120 gallons and one is 80 gallons. We could not determine the age of the heaters, but one appears newer than the other. The heater appears to serve the café also has a water meter at the inlet.

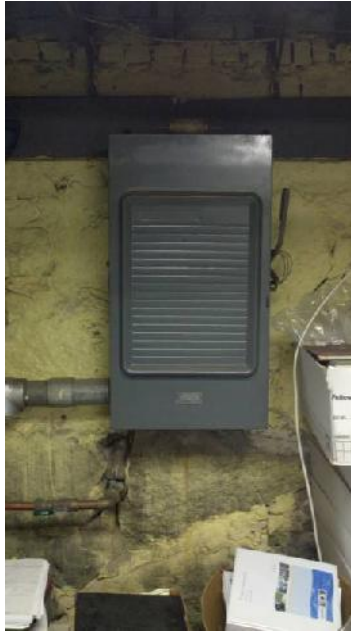
Figure 6 - Service Disconnect

The existing electrical service is a 400 amp, 120/240V, 1-phase service that enters below grade along the Southwest corner of the building and terminates to a 400 amp fused disconnect. Feeders in a 4" conduit are routed from the fused disconnect to a three socket meter array located in an electrical closet of the Health Department. The meter sockets power various electrical panels and disconnects.

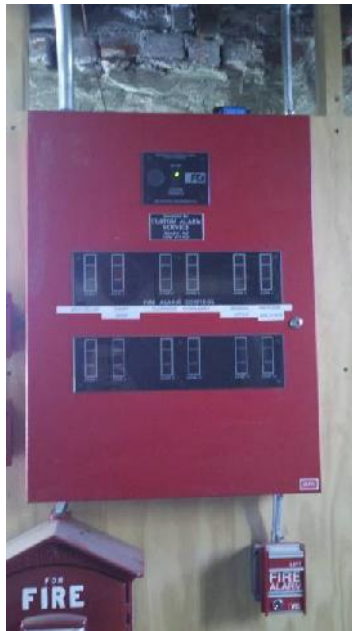
Figure 8 - Fire Alarm Panel

The existing fire alarm system is a conventional audible 12-zoned system manufactured by Fire Control Instruments. The panel is located in the Northwest corner of the basement and is functional and in good condition. Horn/strobes, strobes, smoke detectors, and pull stations are located throughout the building. The system is monitored by the local fire department via a master box mounted adjacent to the fire alarm panel. There did not appear to be an annunciator panel by the main entrance.
